Palace Hotel Inspection 9/29/2023

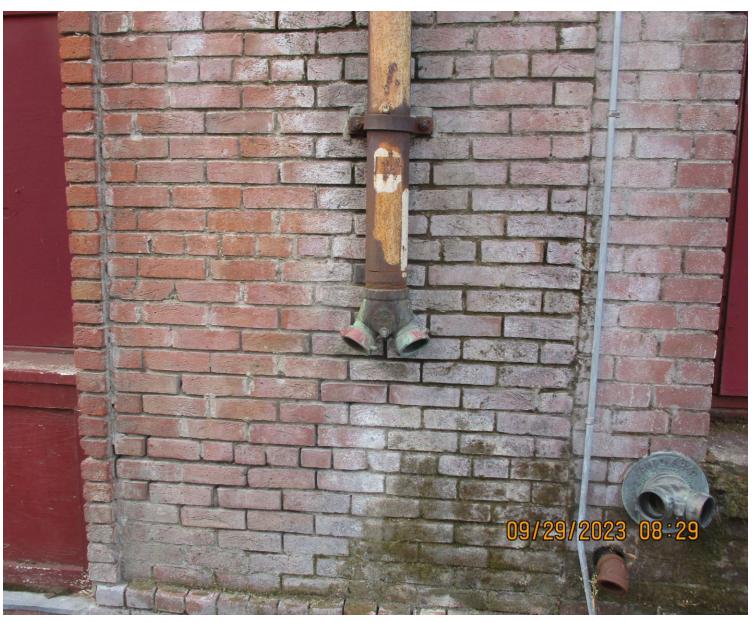
SMITH ST FDC AND STANDPIPE

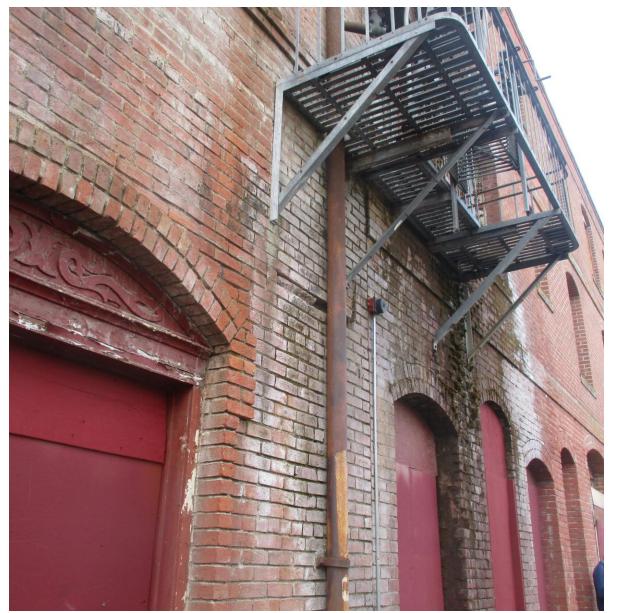
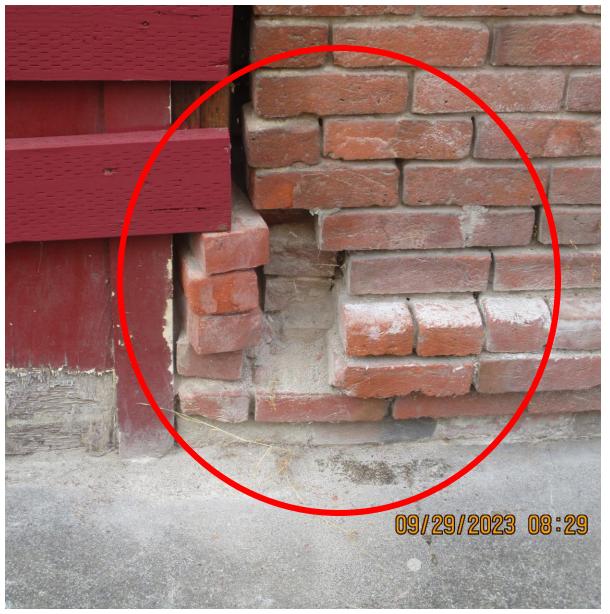
SMITH ST FAILING MORTAR THROUGHOUT BUILDING

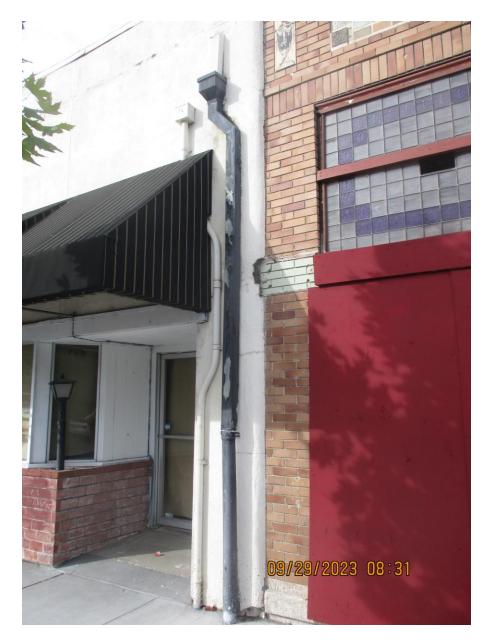
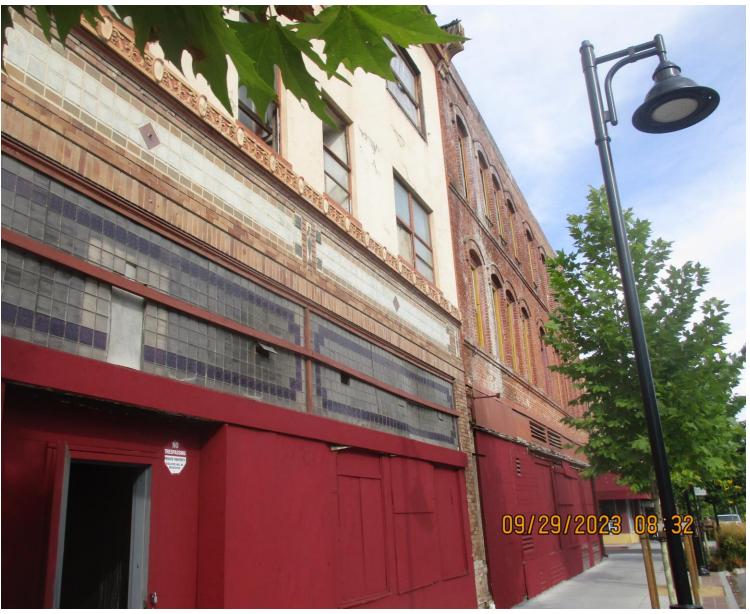
LEAD GLASS FAILURE STATE ST

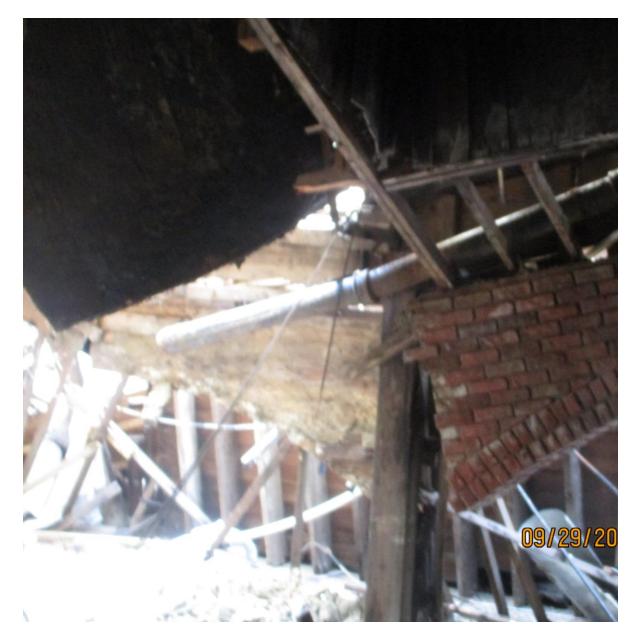
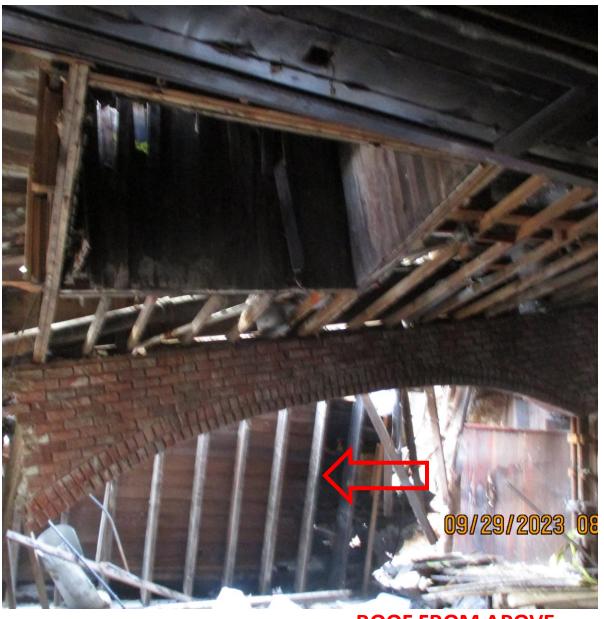
STRUCTURAL FAILURE AND PARTIAL COLLAPSE OF THE ATRIUM ROOF. LOCATION 1 FLOOR.

As a result of the above-described conditions, the historical significance of this building cannot impede the protection of public safety which is of paramount importance. You must take all necessary steps to ensure the safe and timely demolition or stabilization of this building.

In accordance with Section 116.1 of the 2022 California Building Code, YOU ARE HEREBY NOTIFIED: that the City of Ukiah is hereby issuing a formal order requiring you as the property owner and managing member of the owner to initiate the demolition or stabilization of the structurally unsound building. Respond to this notice with a permit application and your proposed plan within 30 days.

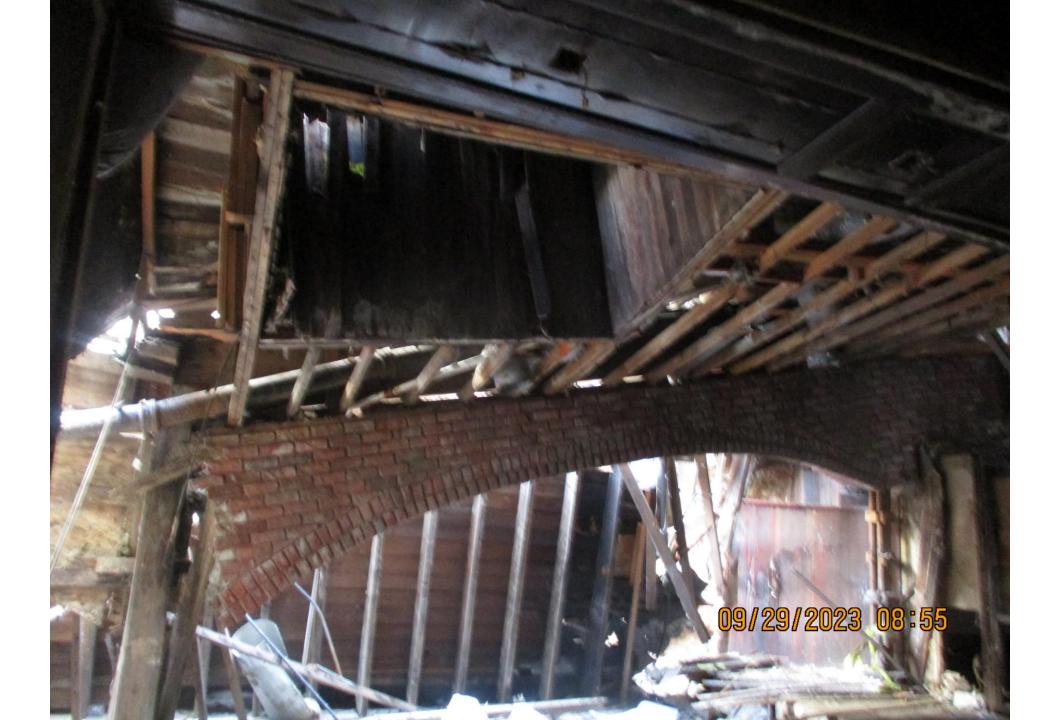
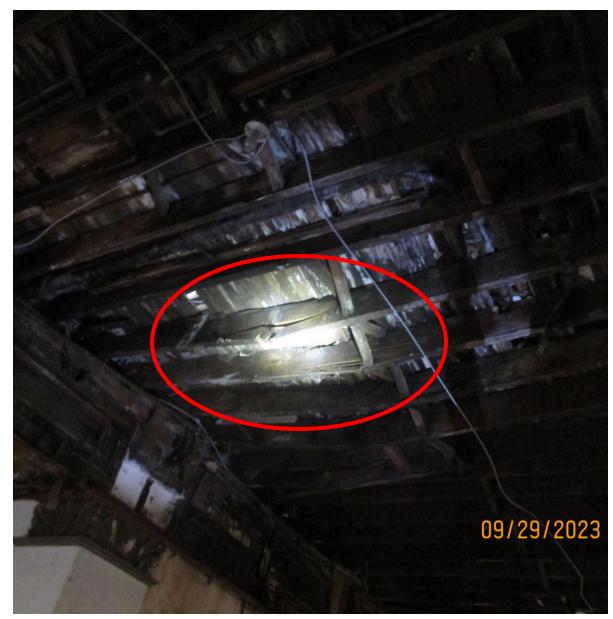
1ST FLOOR: 2ND FLOOR STRUCTURAL FAILURE

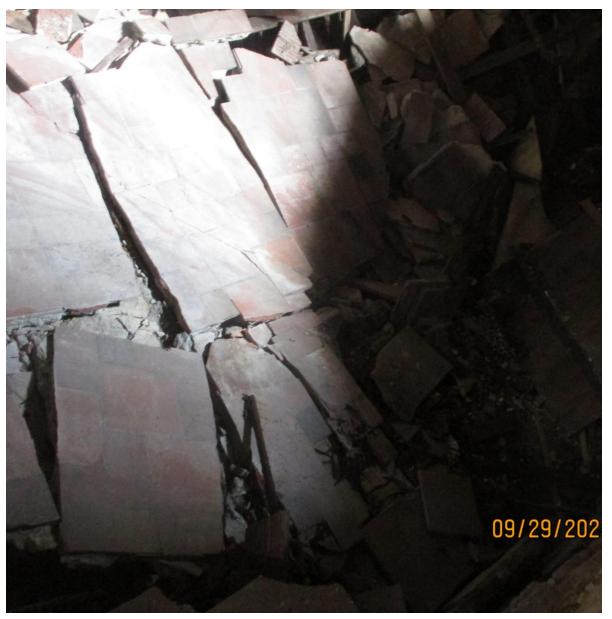
1ST FLOOR LOOKING AT 2ND FLOOR, AT STATE ST SIDE OF BUILDING. FLOOR JOIST STRUCTURAL FAILURE

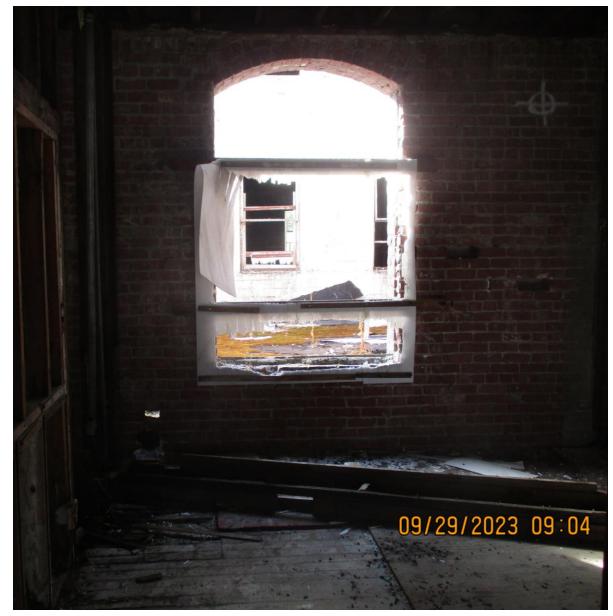
1ST FLOOR BRICK WALL STRUCTURAL FAILURE

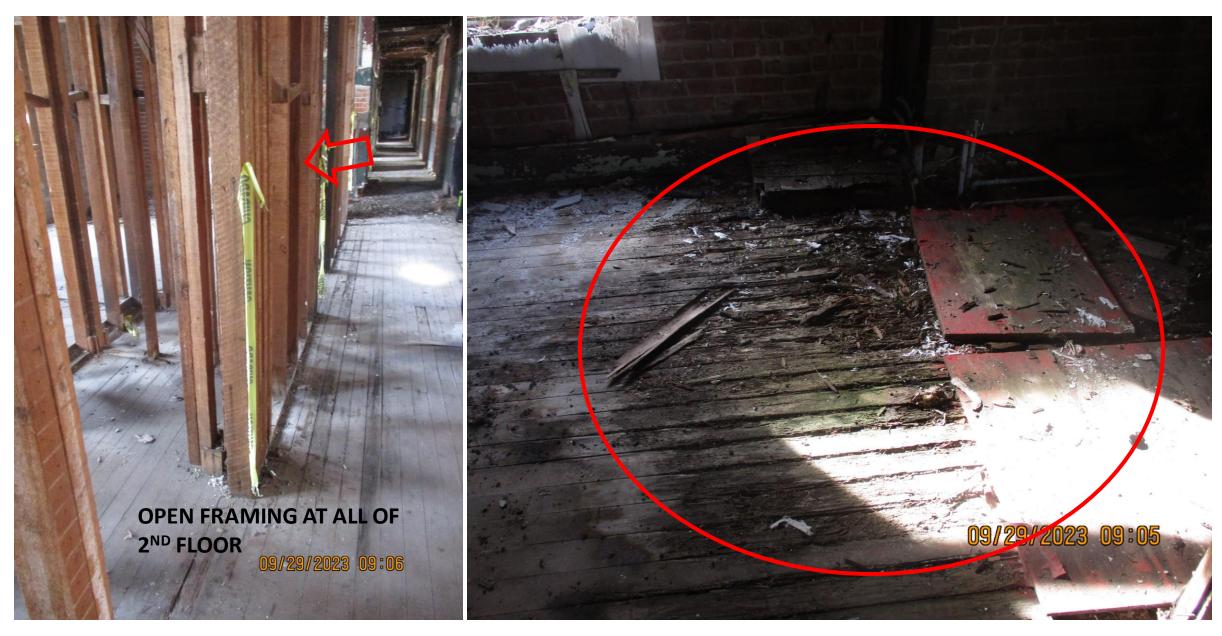
2^{ND} FLOOR, FLOOR JOIST STRUCTURAL FAILURE, AND ROT

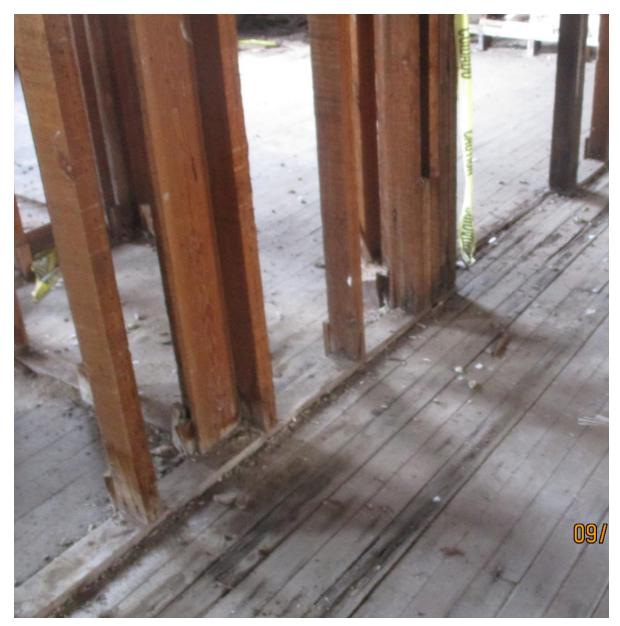
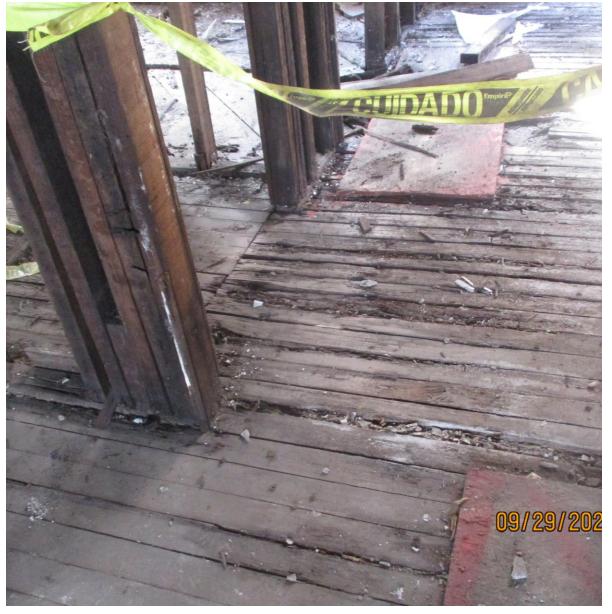
2ND FLOOR UNEVEN AND COMPROMISED, SMITH ST SIDE. DRY-ROT FLOOR ALSO COMPROMISED

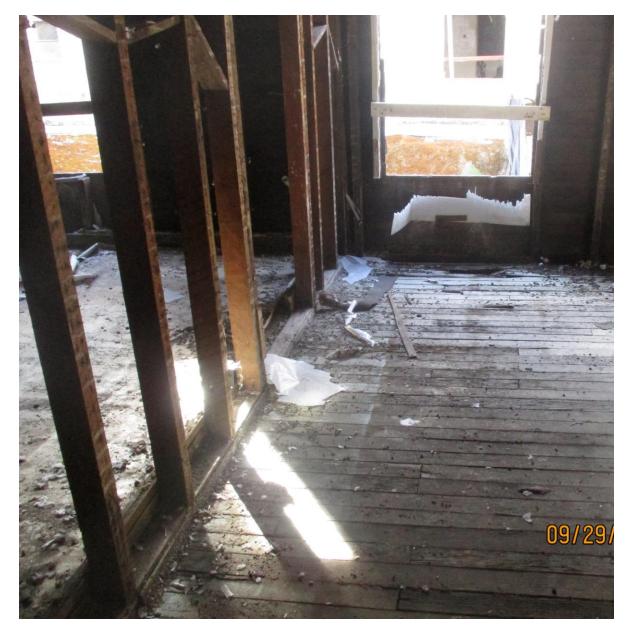
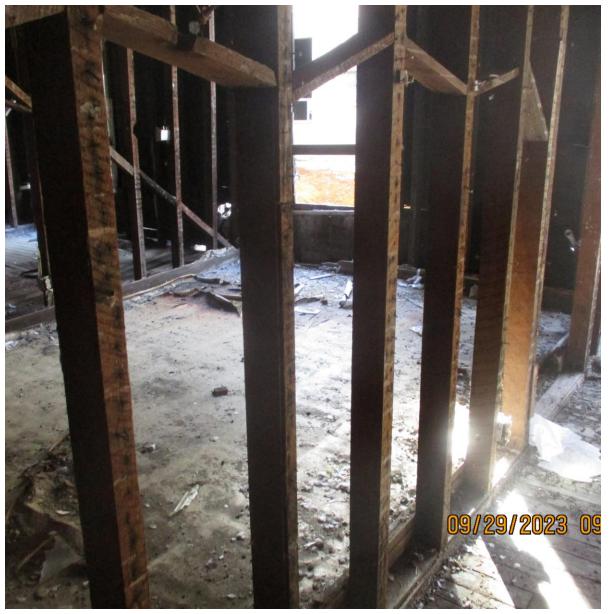
2^{ND} FLOOR UNEVEN AND COMPROMISED, SMITH ST SIDE. DRY-ROT FLOOR ALSO COMPROMISED

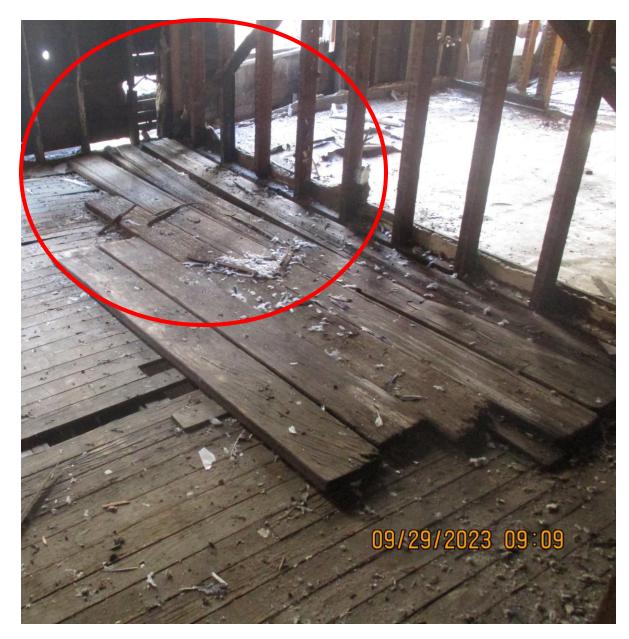
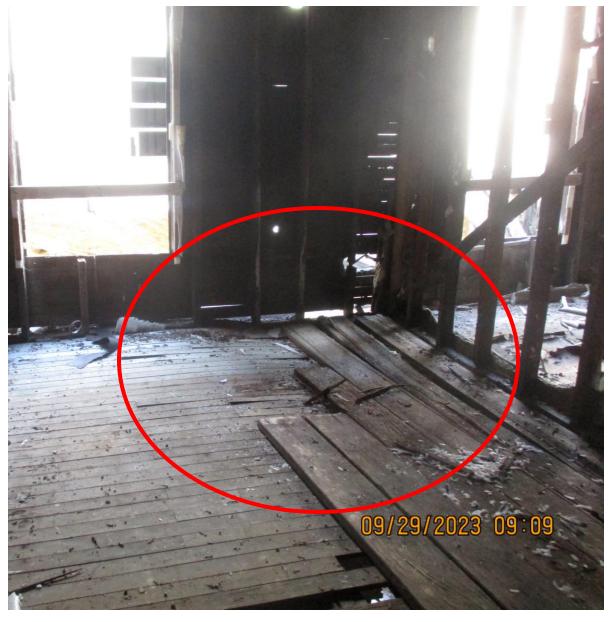
2ND FLOOR UNEVEN AND COMPROMISED, SMITH ST SIDE. DRY-ROT FLOOR ALSO COMPROMISED, STRUCTURAL FAILURE

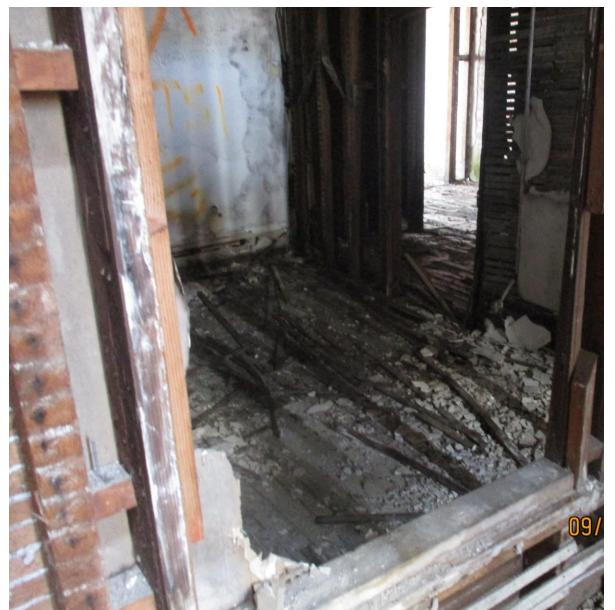
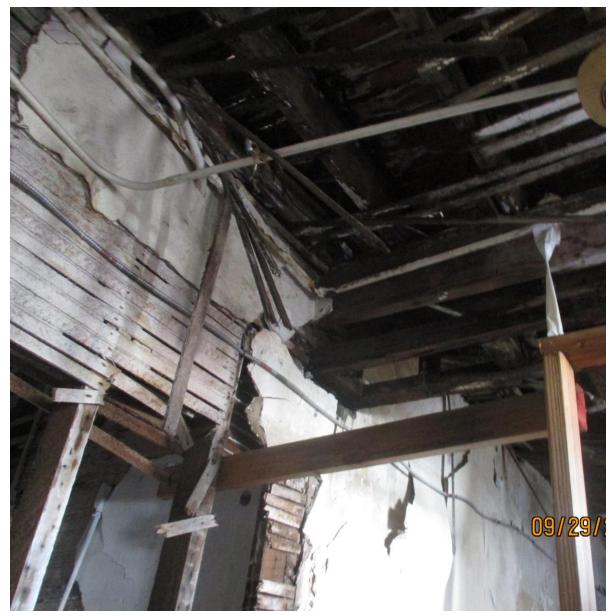
2ND FLOOR FIRE HAZARD EXPOSED WOOD

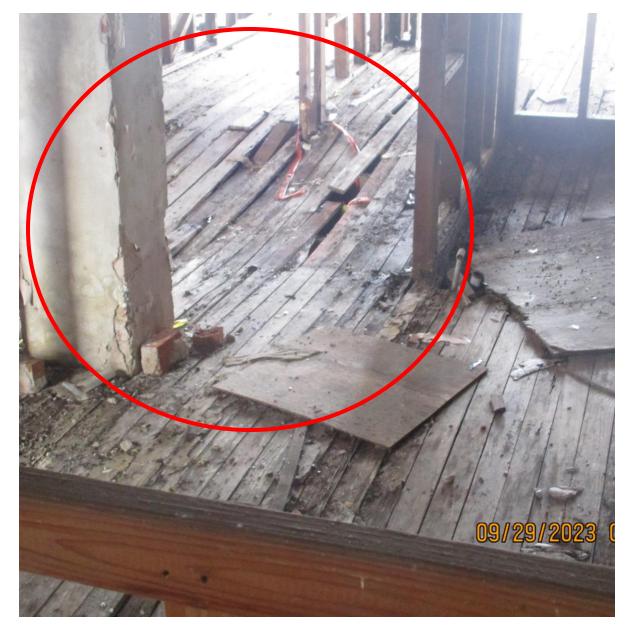
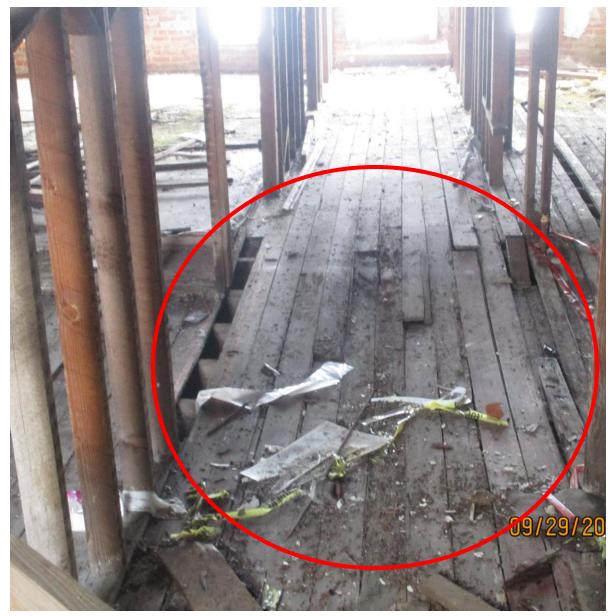
3RD FLOOR STATE ST SIDE: FLOOR JOIST STRUCTURAL FAILURE, AND ROT

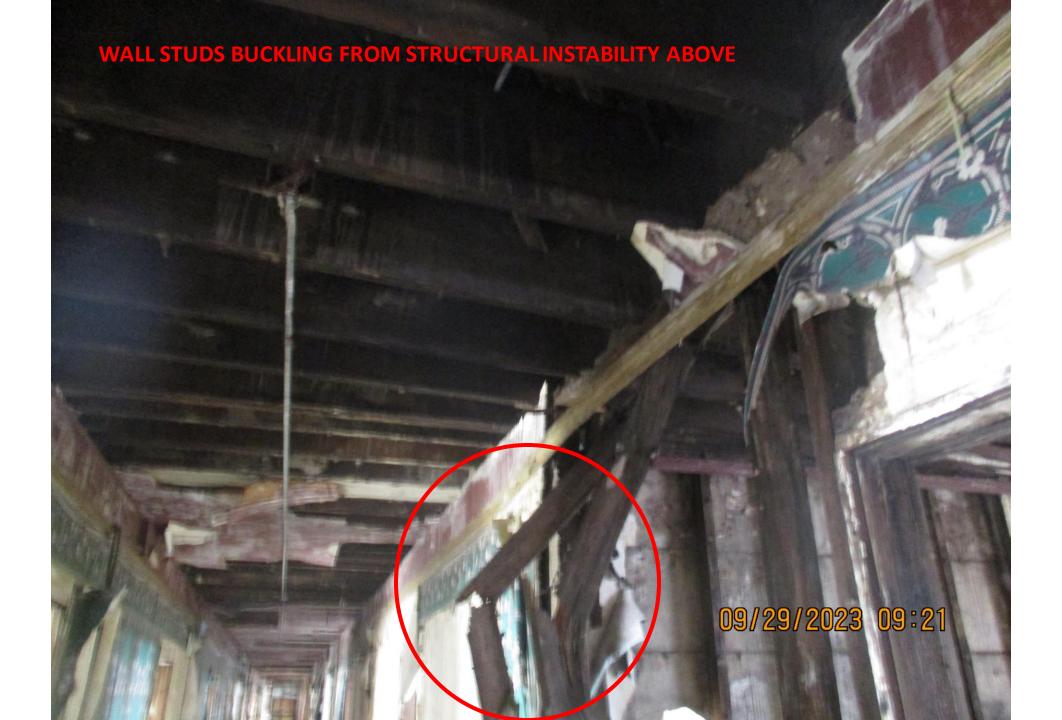
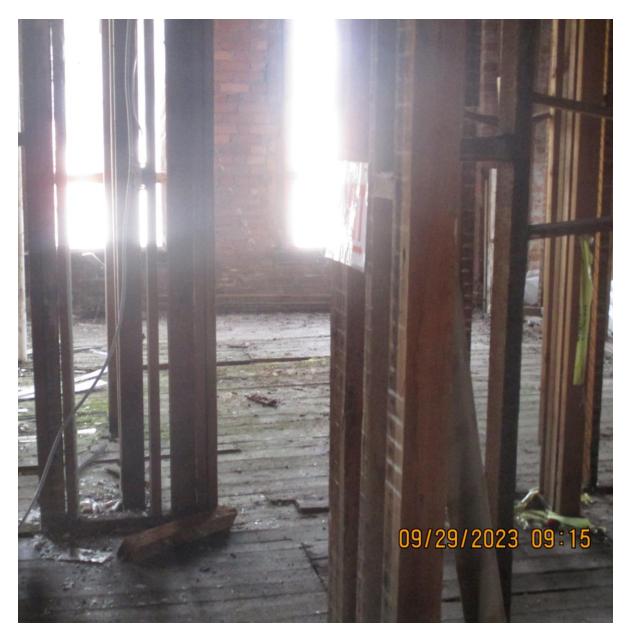
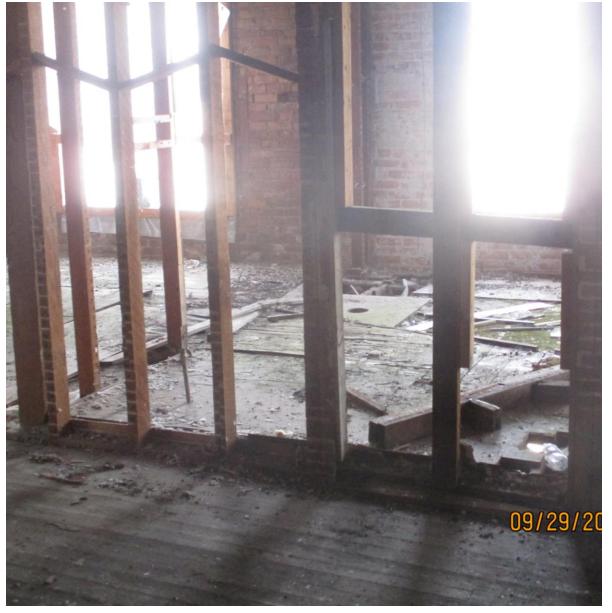
3RD FLOOR STATE ST SIDE: FLOOR JOIST STRUCTURAL FAILURE, AND ROT

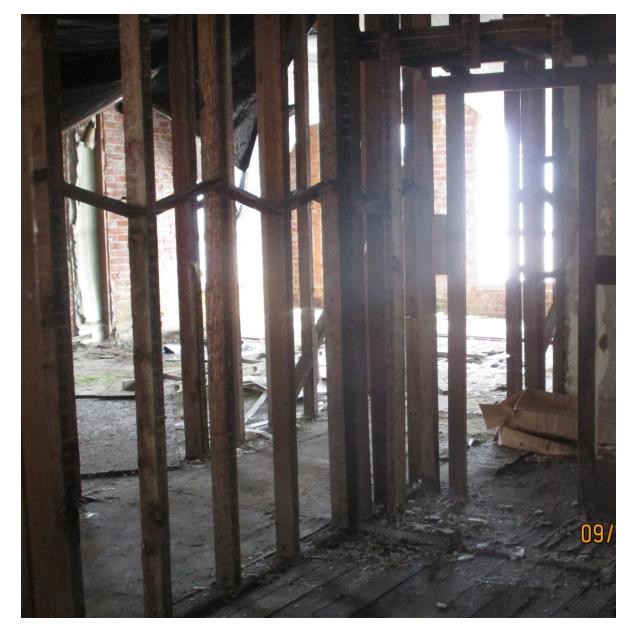
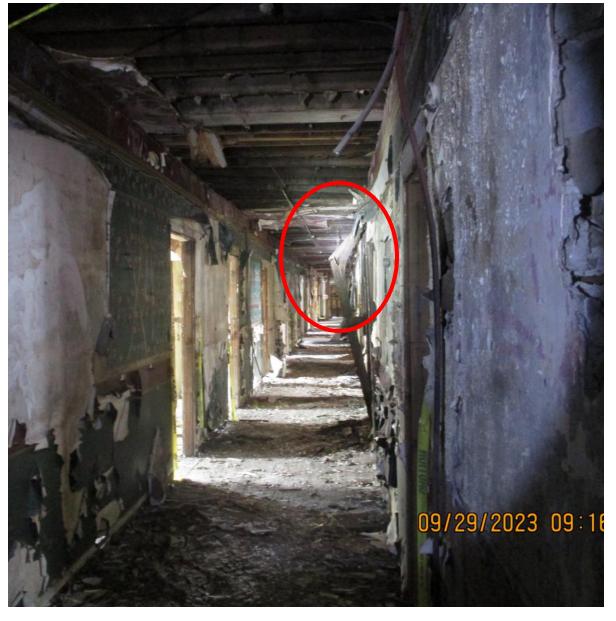
3RD FLOOR STATE ST SIDE: FLOOR JOIST STRUCTURAL FAILURE, AND ROT

WALL STUDS BUCKLING FROM STRUCTURAL INSTABILITY ABOVE

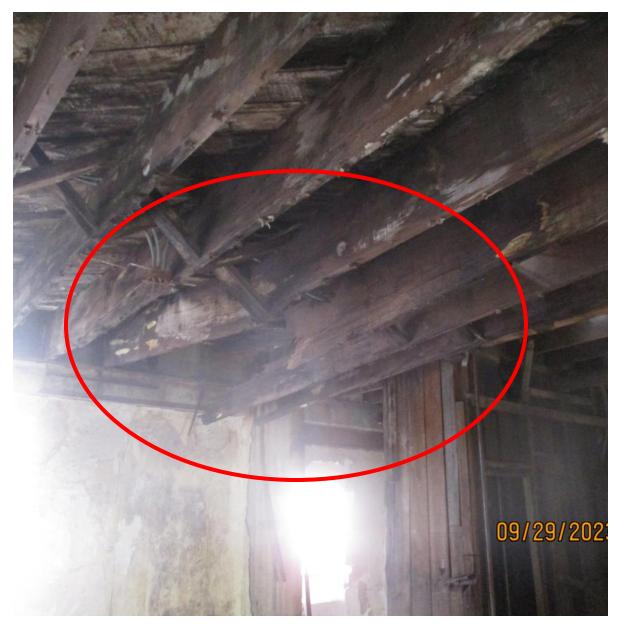
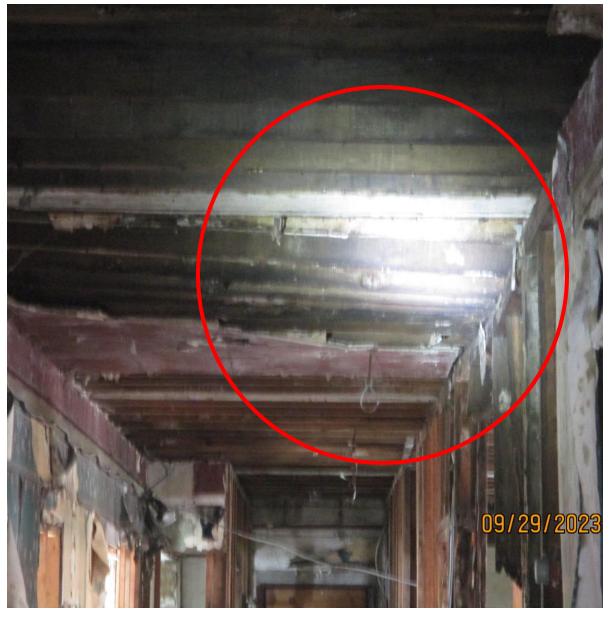
2nd FLOOR LOOKING AT 3rd FLOOR. FLOOR JOIST STRUCTURAL FAILURE

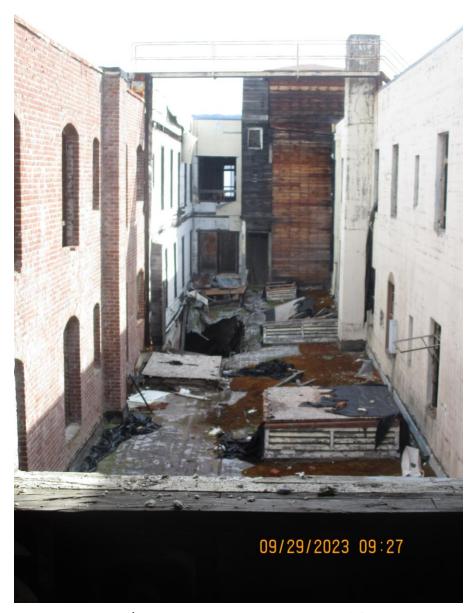
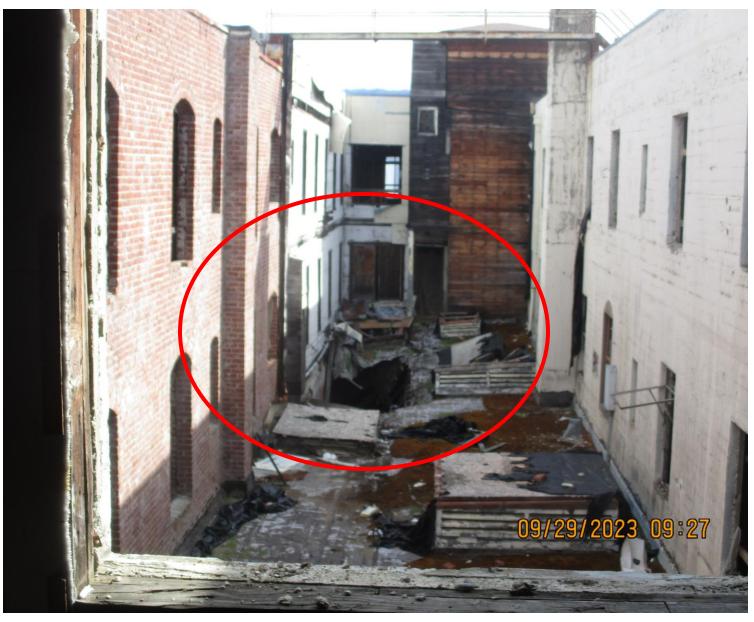
3rd FLOOR LOOKING AT 2ND FLOOR ATRIUM. FLOOR JOIST/ROOF STRUCTURAL FAILURE

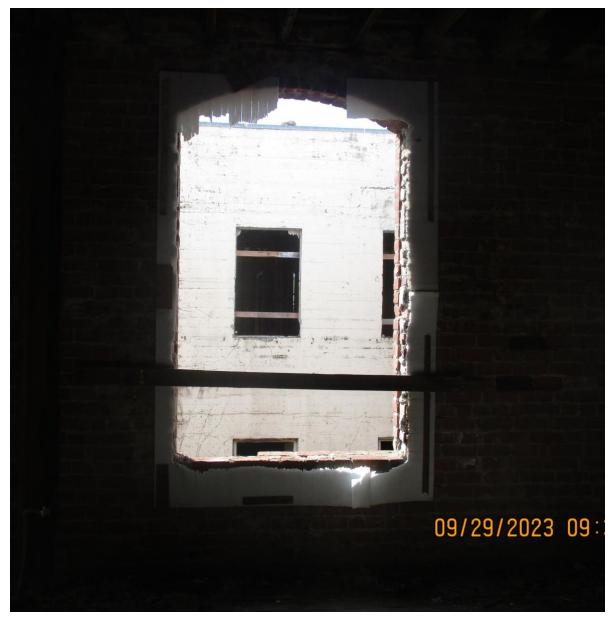
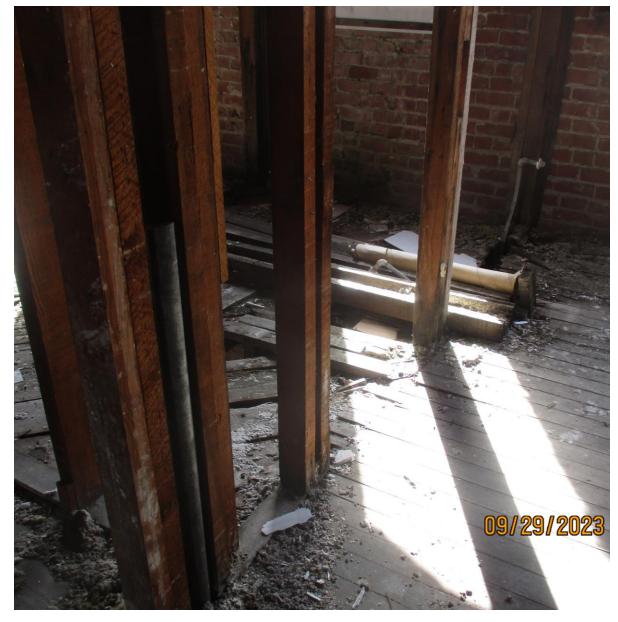
3RD FLOOR: OPEN TO WEATHER

STRUCTURALLY COMPROMISED FLOOR

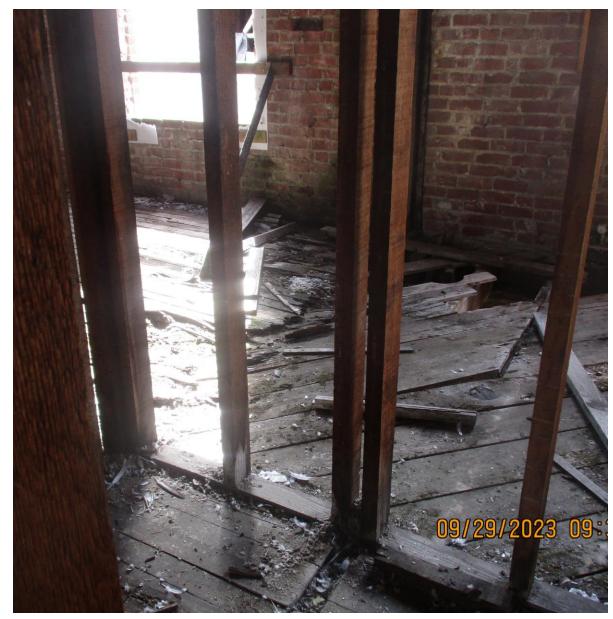
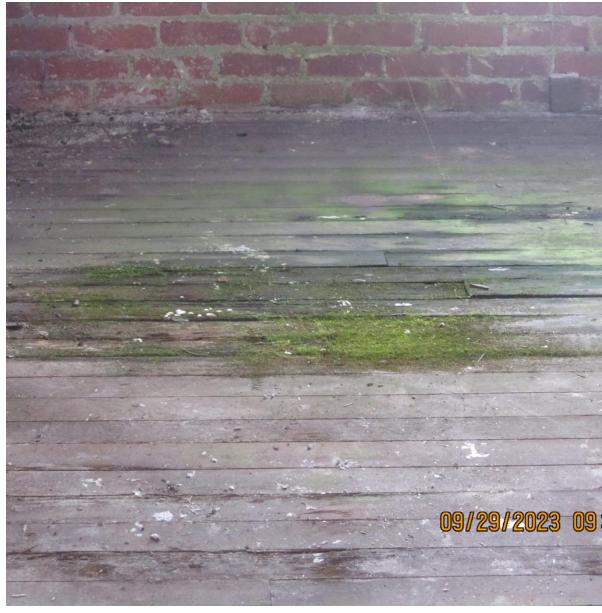
3RD FLOOR UNEVEN AND COMPROMISED, SMITH ST SIDE. DRY-ROT FLOOR ALSO COMPROMISED, STRUCTURAL FAILURE

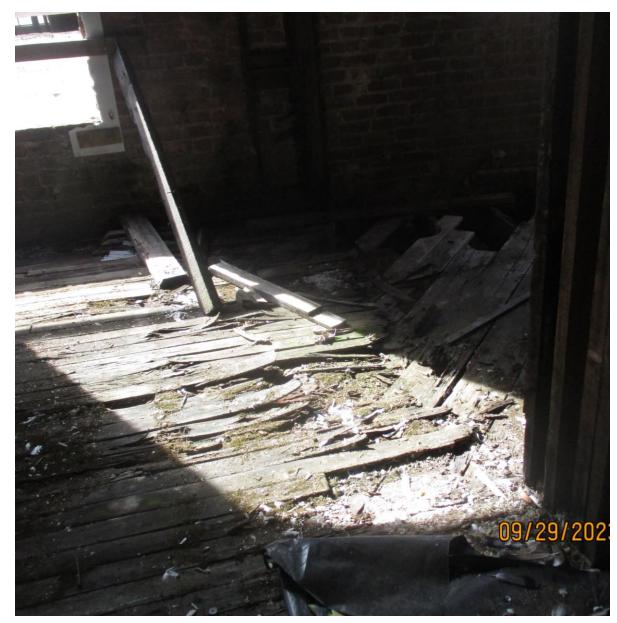
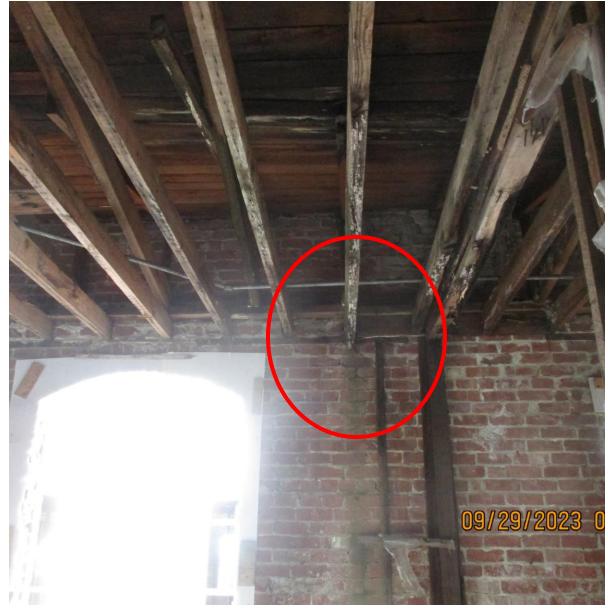
3RD FLOOR UNEVEN AND COMPROMISED, SMITH ST SIDE. DRY-ROT FLOOR ALSO COMPROMISED, STRUCTURAL FAILURE

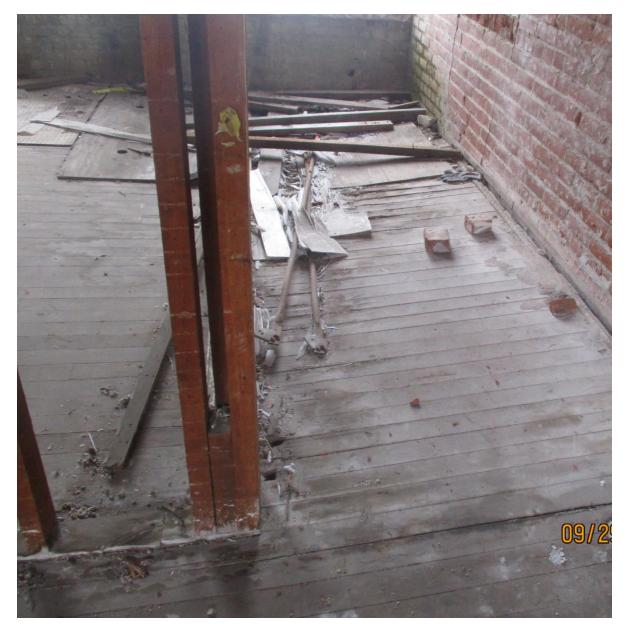
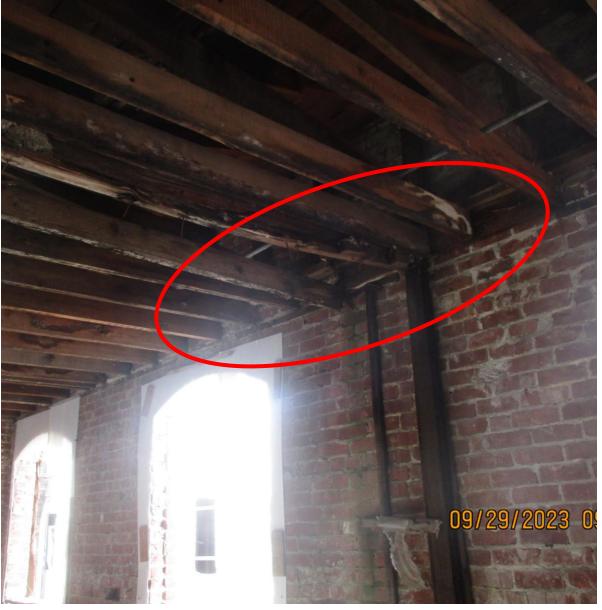
3RD FLOOR UNEVEN AND COMPROMISED, SMITH ST SIDE. DRY-ROT FLOOR ALSO COMPROMISED, STRUCTURAL FAILURE

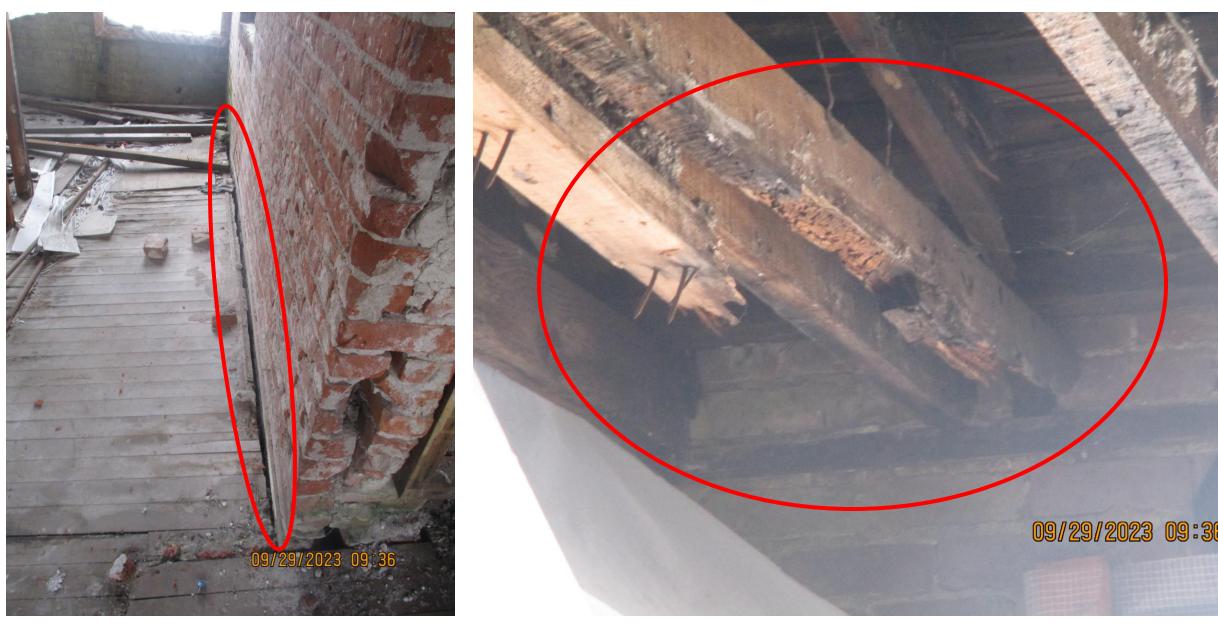
3RD FLOOR UNEVEN AND COMPROMISED, SMITH ST SIDE. DRY-ROT FLOOR ALSO COMPROMISED, STRUCTURAL FAILURE

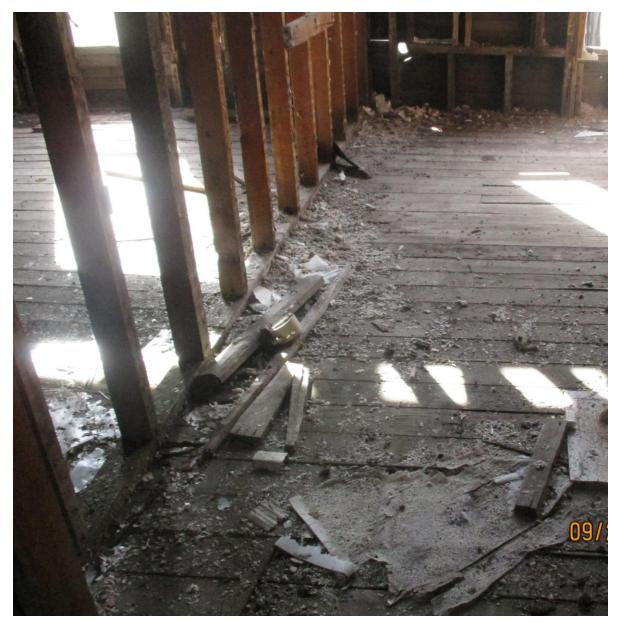
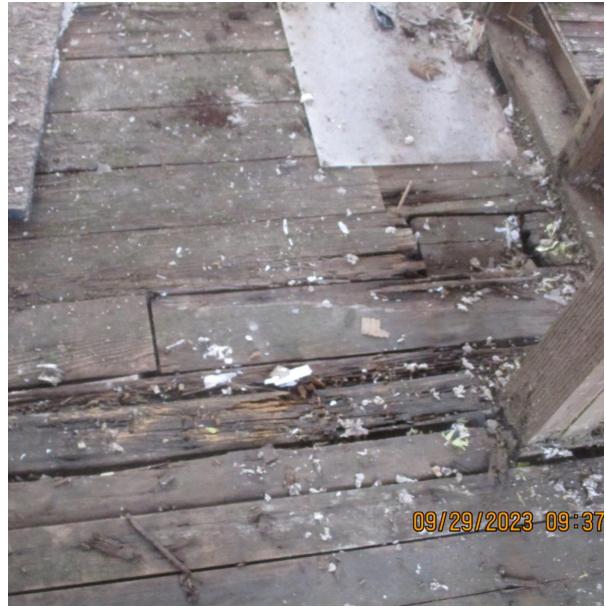
3RD FLOOR UNEVEN AND COMPROMISED, SMITH/STATE. DRY-ROT FLOOR ALSO COMPROMISED, STRUCTURAL FAILURE

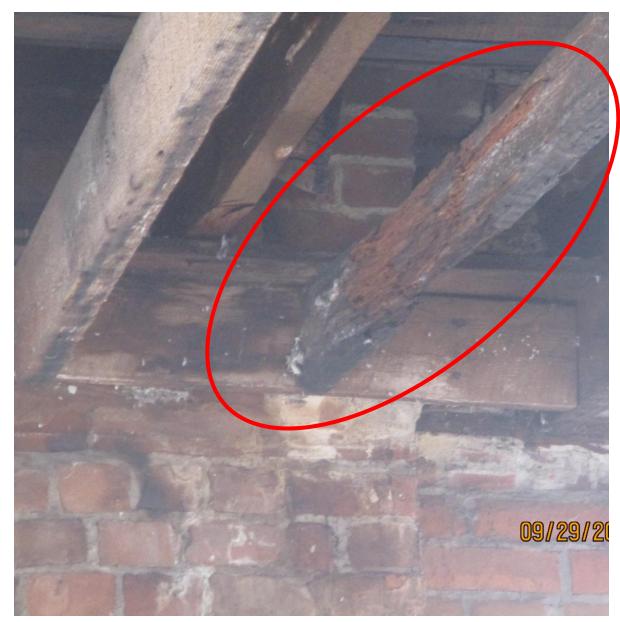
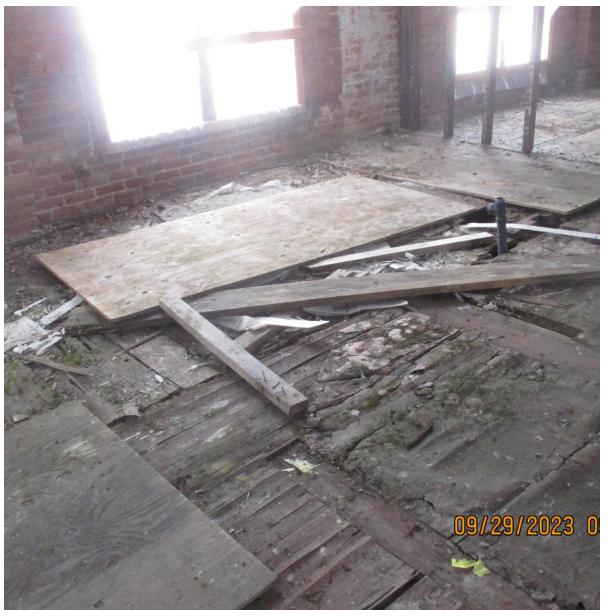
3RD FLOOR UNEVEN AND COMPROMISED, SMITH/STATE. DRY-ROT FLOOR ALSO COMPROMISED, STRUCTURAL FAILURE

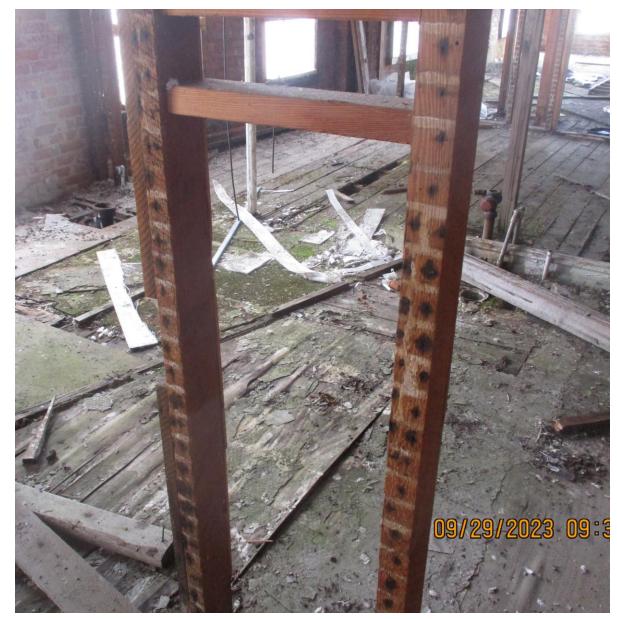
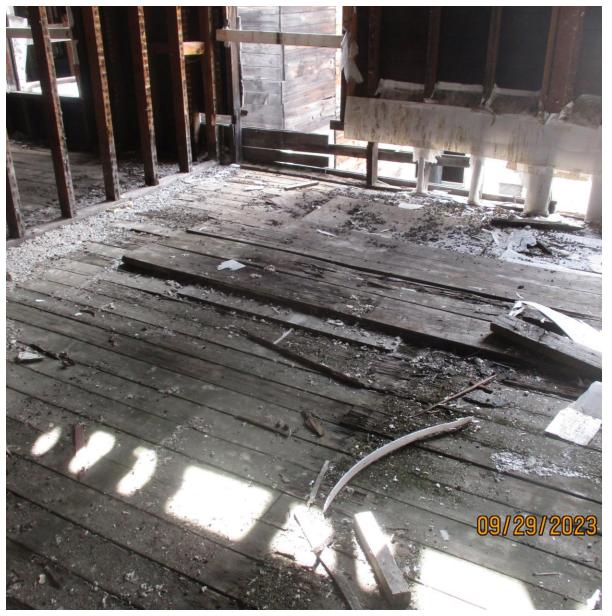
3RD FLOOR UNEVEN AND COMPROMISED, SMITH/STATE. DRY-ROT FLOOR ALSO COMPROMISED, STRUCTURAL FAILURE

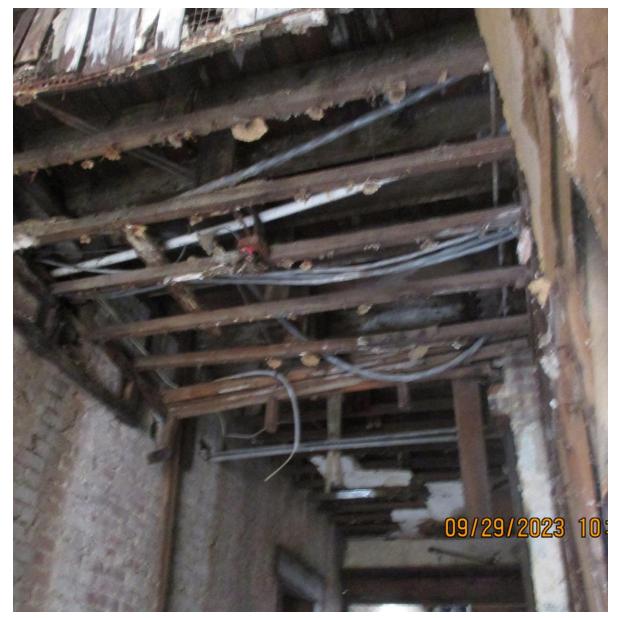
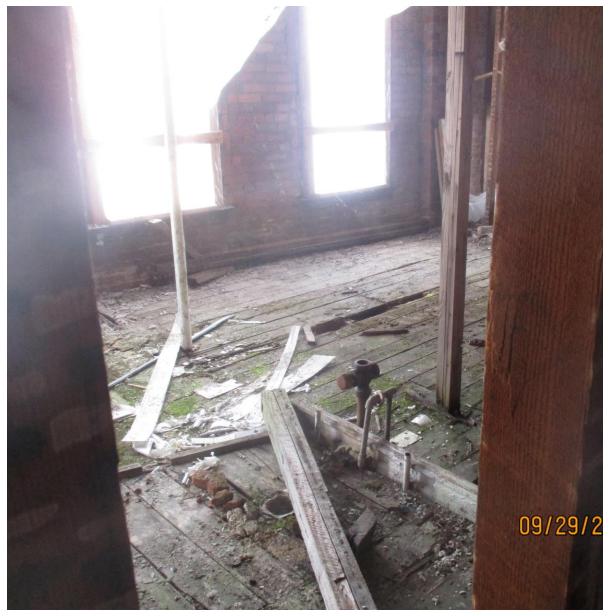
3RD FLOOR UNEVEN AND COMPROMISED, SMITH/STATE. DRY-ROT FLOOR ALSO COMPROMISED, STRUCTURAL FAILURE

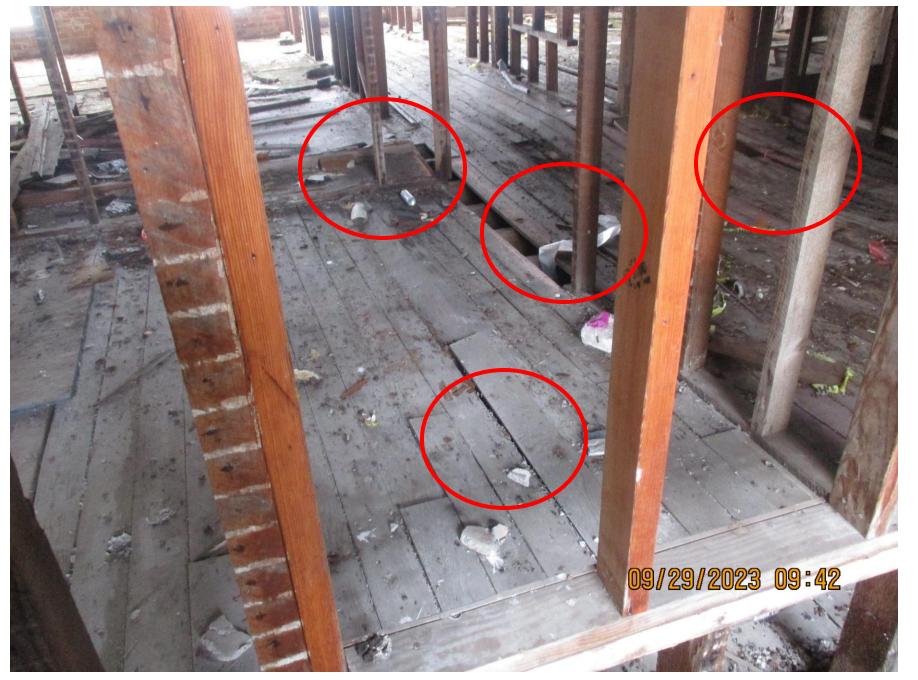
3RD FLOOR UNEVEN AND COMPROMISED, STATE. DRY-ROT FLOOR ALSO COMPROMISED, STRUCTURAL FAILURE

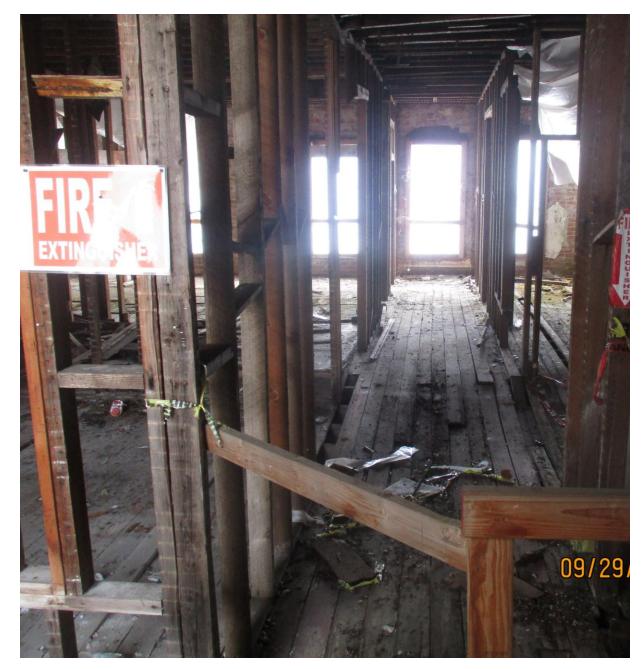
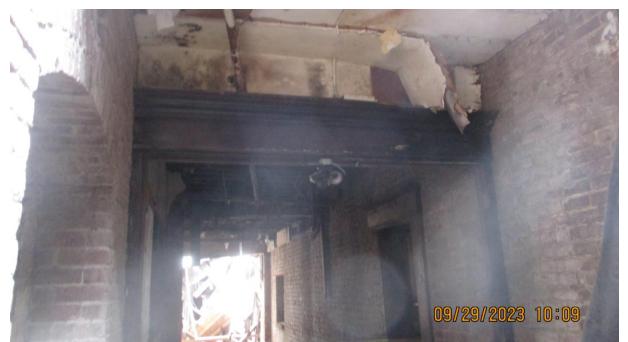
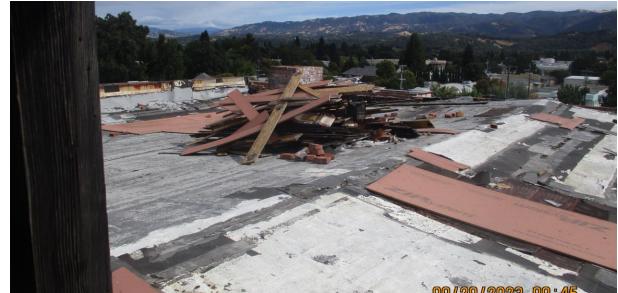
3RD FLOOR UNEVEN AND COMPROMISED, STATE. DRY-ROT FLOOR ALSO COMPROMISED, STRUCTURAL FAILURE
