# Final Report

Utility Cut Impact Assessment and Fee Development  
July 2022

# Utility Cut Impact Assessment and Fee Development

## Ukiah, CA

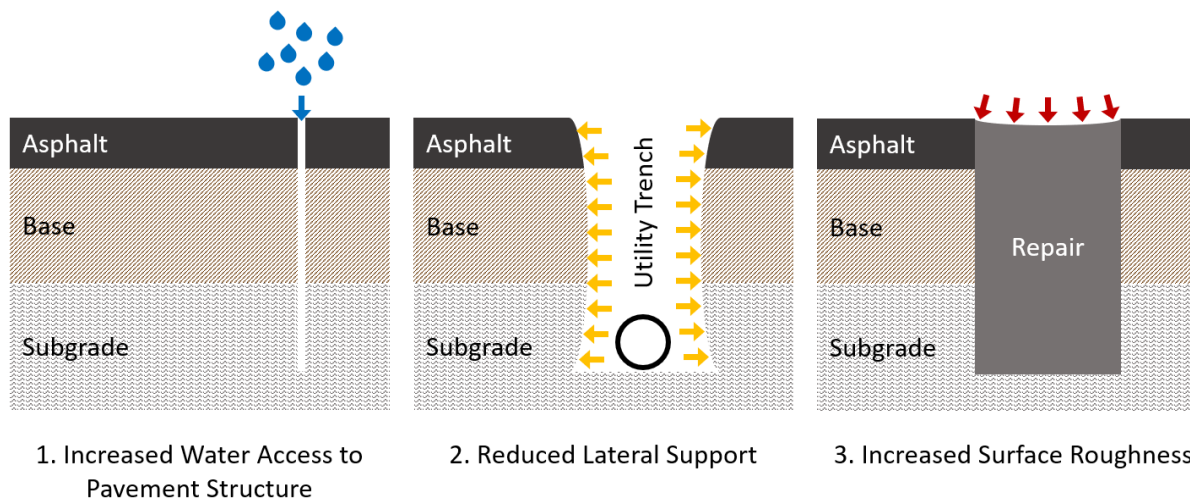
**Figure 1. Utility Cut Damage Mechanisms**

First, cutting a pavement structure creates an entry point for water that can damage the underlying pavement layers. Second, removing pavement layers creates a plane of weakness where the pavement structure may not be adequately supported laterally – particularly during underground utility maintenance, but also after restoration. Third, repairing the pavement can introduce roughness if it does not closely match the adjacent pavement structure. Rough pavements can cause vehicles to bounce, which creates greater loads on the pavement and leads to more rapid deterioration (Tarakji 1995, Wilde et al. 2002).

Underground utility work can damage pavements in three general ways, as illustrated in Figure 1.

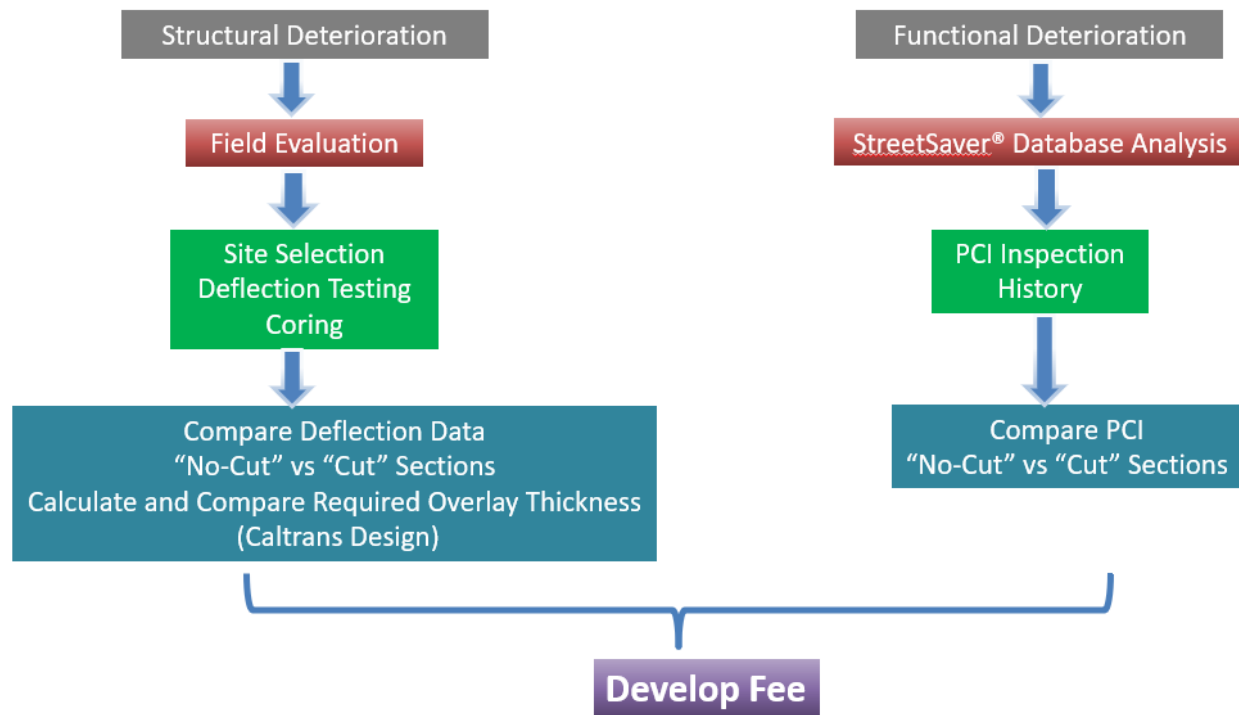
The flowchart shown in Figure 2 presents the methodology for this study. Field testing was used to estimate the loss of structural capacity due to cuts (structural evaluation). Distress data from the City's StreetSaver® database were analyzed to estimate the impact of cuts on pavement condition and lifespan (functional evaluation).

**Figure 2. Technical Approach**

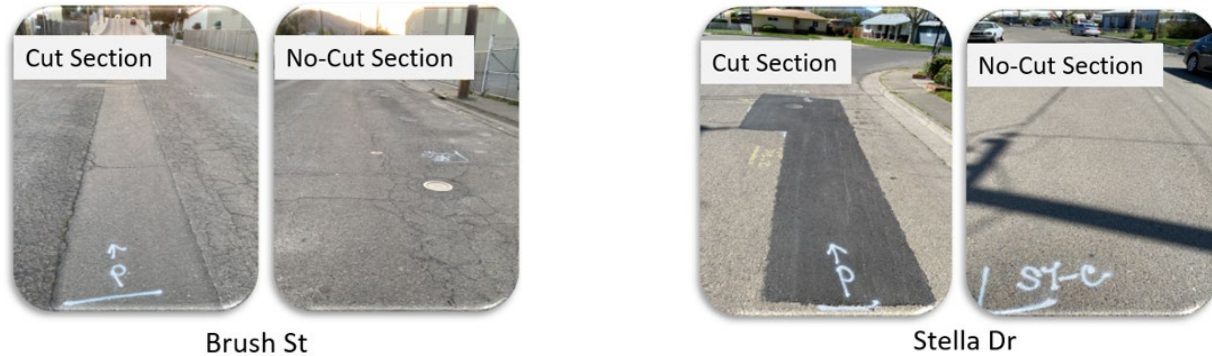
Sixteen sites were selected; each site had a section with a cut and one without a cut (Figure 3 has examples of test sites). The sections with and without cuts will be often referred to as “cut section” and “no-cut section,” respectively, in this document.

**Figure 3. Examples of Site Selection**

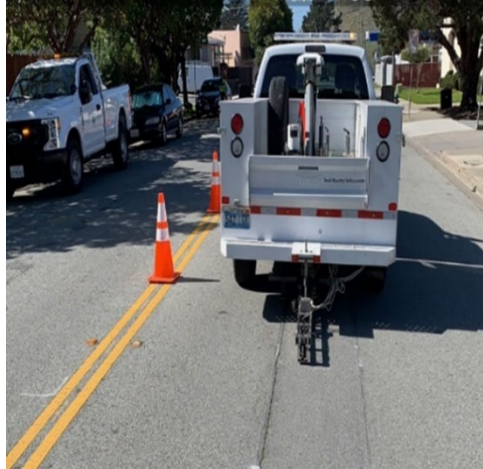
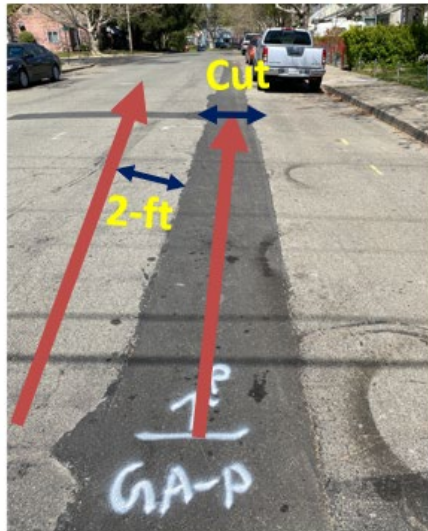
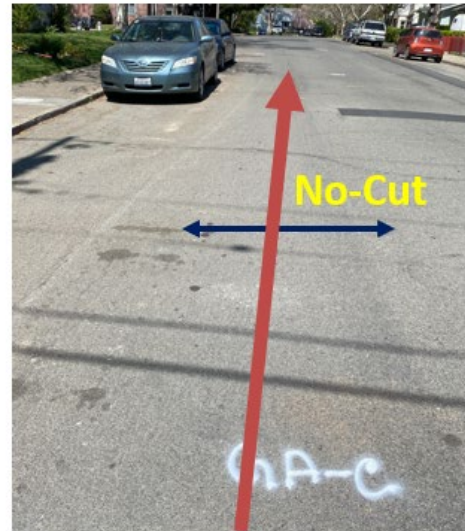
Deflection testing was performed using an FWD, which delivers a transient impulse load to the pavement surface and measures the resultant pavement response in terms of deflection. Testing was conducted along the cut, 2 feet away from the cut (known as the zone of influence) as well as on sections with no cuts (see Figure 4).

GA-P: P is the Patch Section or Cut Section

GA-C: C is the Control Section or No-Cut Section

**Figure 4. Falling Weight Deflectometer Testing Layout**

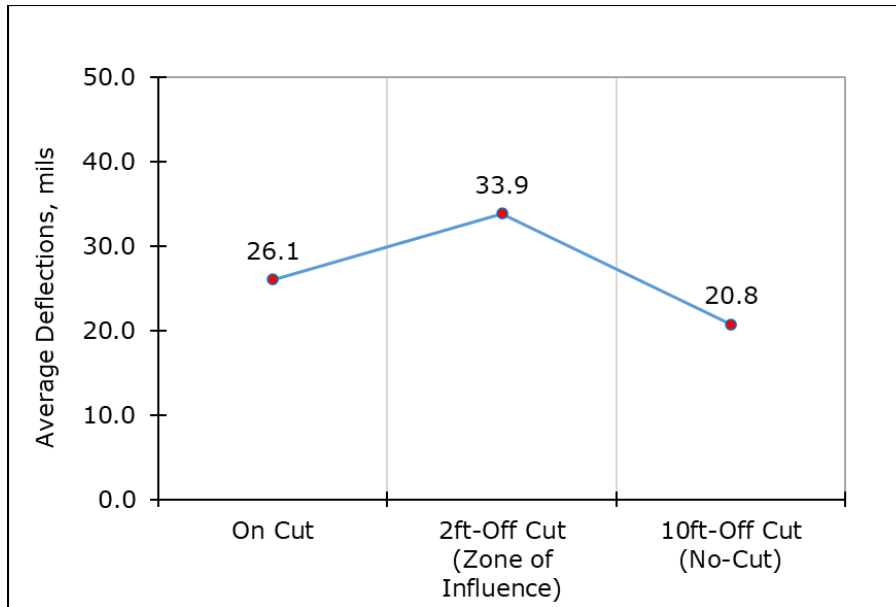
As mentioned, the deflection data were used to measure the relative loss of structural capacity resulting from the presence of utility cuts. Therefore, the deflection at a no-cut section was expected to be lower than the deflection on the cut or 2-ft near the cuts if at a cut section or at a section in the zone of influence. Figure 5 illustrates the expected trend from one of the testing sites in Ukiah.

**Figure 5. Expected Deflection Trend (Low Gap Road in Ukiah)**

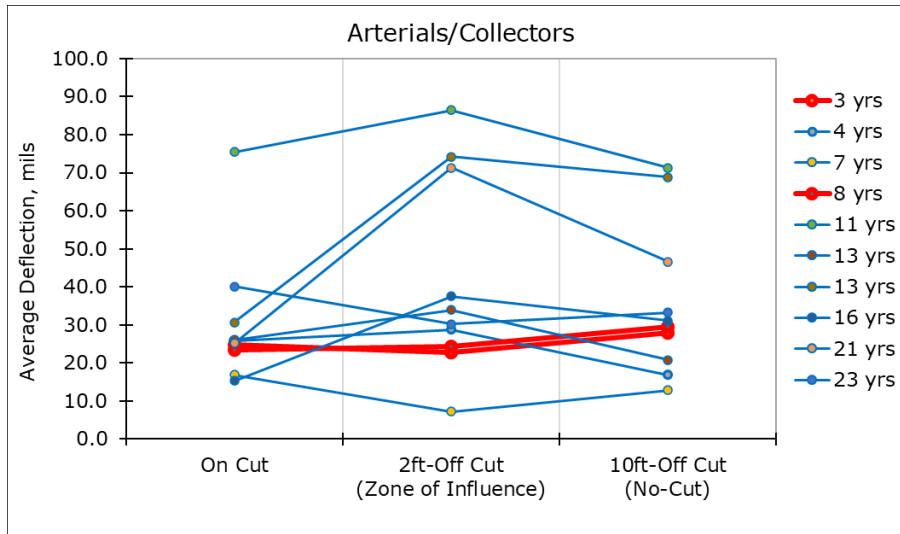
Figure 6 and Figure 7 present the deflection trend results for the selected test sites. (arterials/collectors and residential, respectively). The blue lines indicate the expected deflection trend.

It was observed that 75% of the sites were adversely affected by the presence of the utility cuts. The blue lines indicate expected deflection trend or structural damage due to the presence of utility cuts. In other words, the average deflection measurements taken either on the cuts or adjacent to the cuts (within the zone of influence) were higher than the average deflection measurement taken in the no-cut sections. As discussed in Section 2.1, this indicates that the no-cut sections would require thinner overlays than the cut-sections. The red lines on the figures indicate sections that did not show this trend. This could mean that cut sections have thicker asphalt structure than no-cut sections.

Figure 6. Deflection Trends for Arterials/Collectors

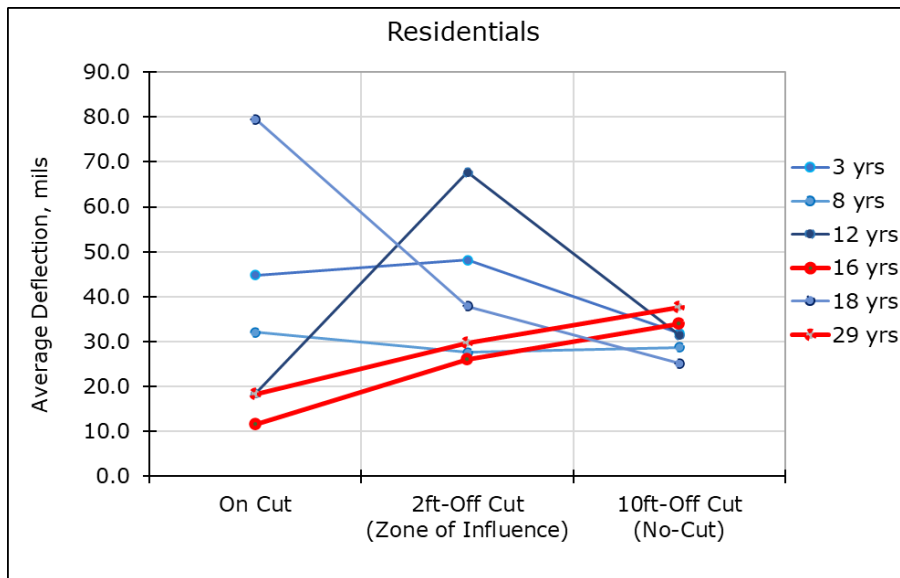
Figure 7. Deflection Trends for Residential

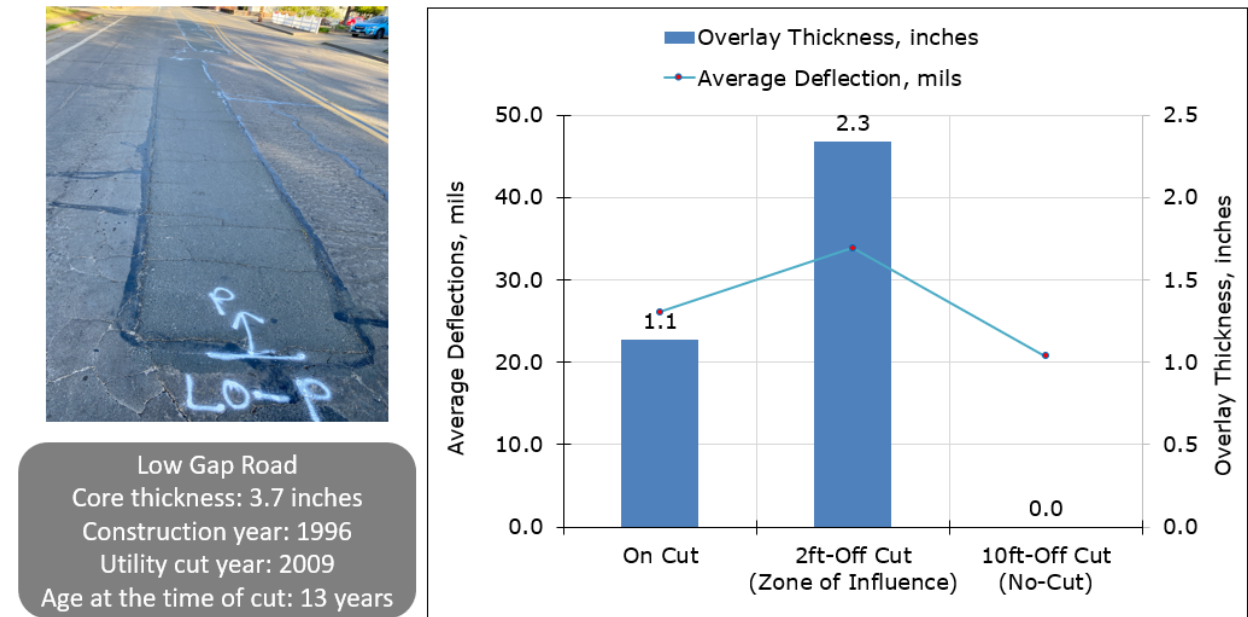
Two examples are shown in Figure 8 and Figure 9. Figure 8 shows the results for Low Gap Road (arterial/collector), where the cut and zone of influence sections would need 1.1-inch and 2.3-inch overlays to meet structural capacity for a TI of 7, respectively. The no-cut section would require no overlay.

**Figure 8. Deflection and Overlay Thickness Trend of Low Gap Road**

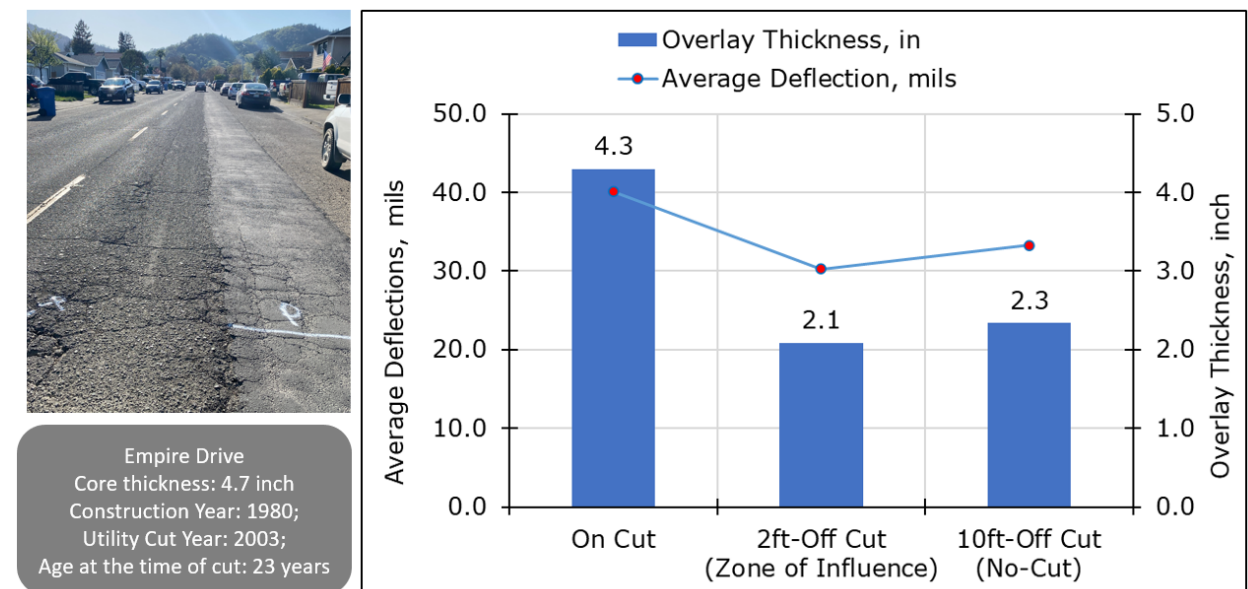
The no-cut section of Empire Drive (Figure 9) would need an overlay of 2.3 inches, which is almost half of what is required on the cut (an overlay thickness of 4.3 inches) to meet the structural capacity for a TI of 7.

**Figure 9. Deflection and Overlay Thickness Trend of Empire Drive**

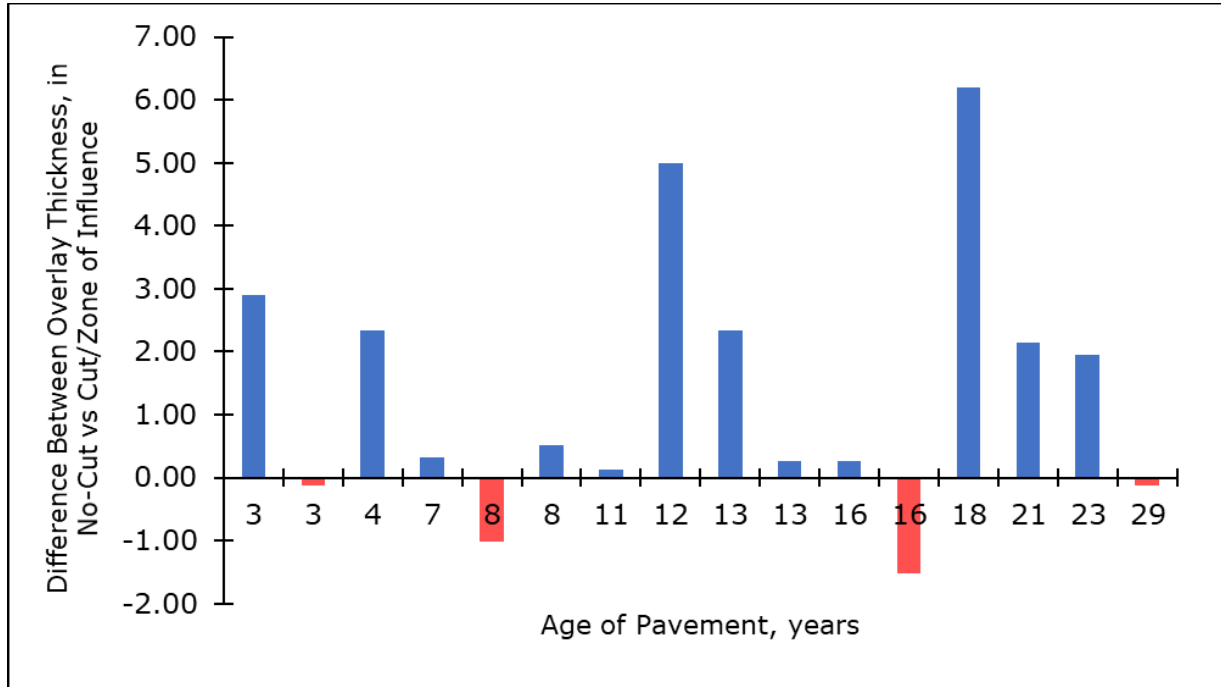
Figure 10 summarizes the differences in overlay thickness between the no-cut section and the maximum value of either the cut or zone of influence section for all sites. The blue bars in Figure 10 indicate the additional overlay thickness needed to compensate for loss in structural capacity when compared to no-cut sections. The

red bars indicate that no overlay is needed in the cut or zone of influence section. It was observed that 75% of the sites would need an average of 2 inches of additional overlay in the cut or zone of influence section to compensate for the loss in structural capacity due to utility cuts.

**Figure 10. Difference in Overlay Thickness**

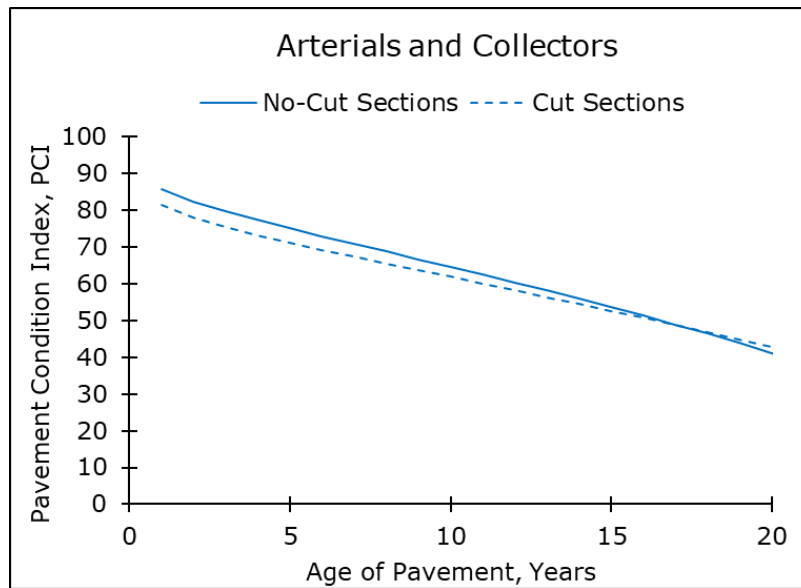
Pavement deterioration curves of cut and no-cut sections for arterials/collectors and residential were developed using the historical data from the City's database. These curves are shown in Figure 11 and Figure 12. These curves indicate the following:

- For arterials/collectors, overall sections with cuts deteriorated more rapidly than sections without cuts for pavements less than 15 years old. Some streets more than 15 years did not exhibit this trend due to the existing distresses present.
- For residential, overall sections with cuts deteriorated more rapidly than sections without cuts within all age groups.

**Figure 11. Pavement Deterioration Curve for Cut and No-Cut Sections – Arterials and Collectors**

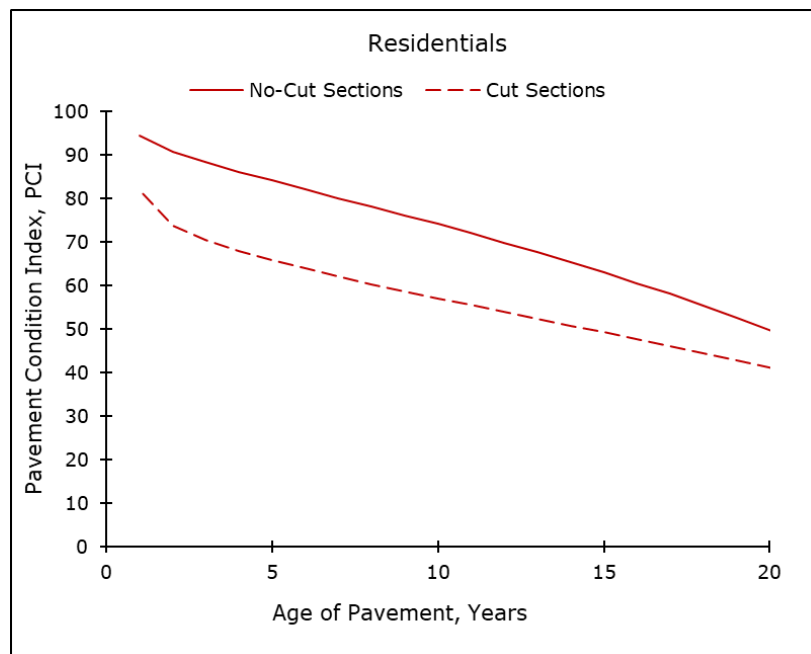
**Figure 12. Pavement Deterioration Curve for Cut and No-Cut Sections – Residential**

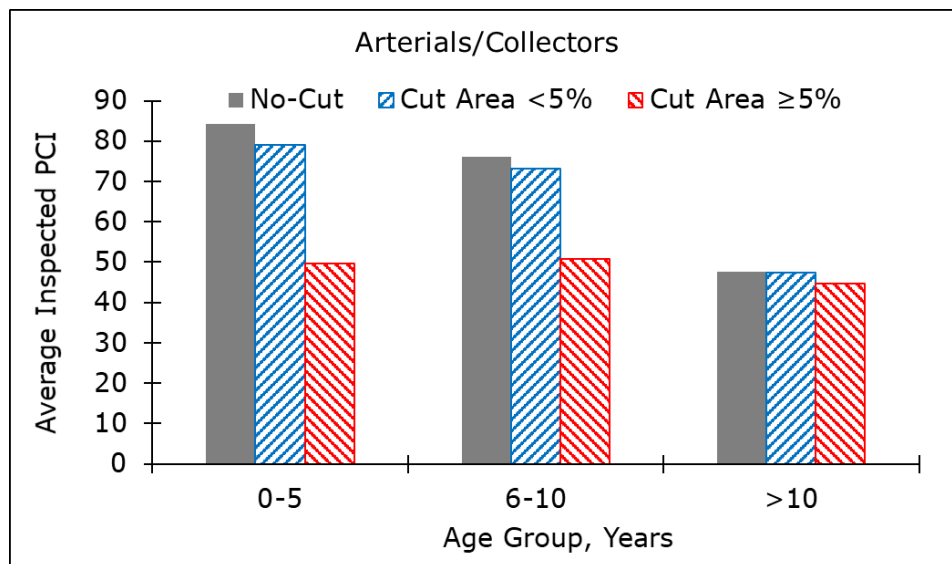
Figure 13 and Figure 14 show the PCI comparison for arterials/collectors and residential, respectively. These figures indicate the following:

- Overall PCI decreased with pavement age.
- PCI decreased as cut size increased.

**Figure 13. PCI Comparison by Functional Class, Age Group and Cut Size – Arterials/Collectors**

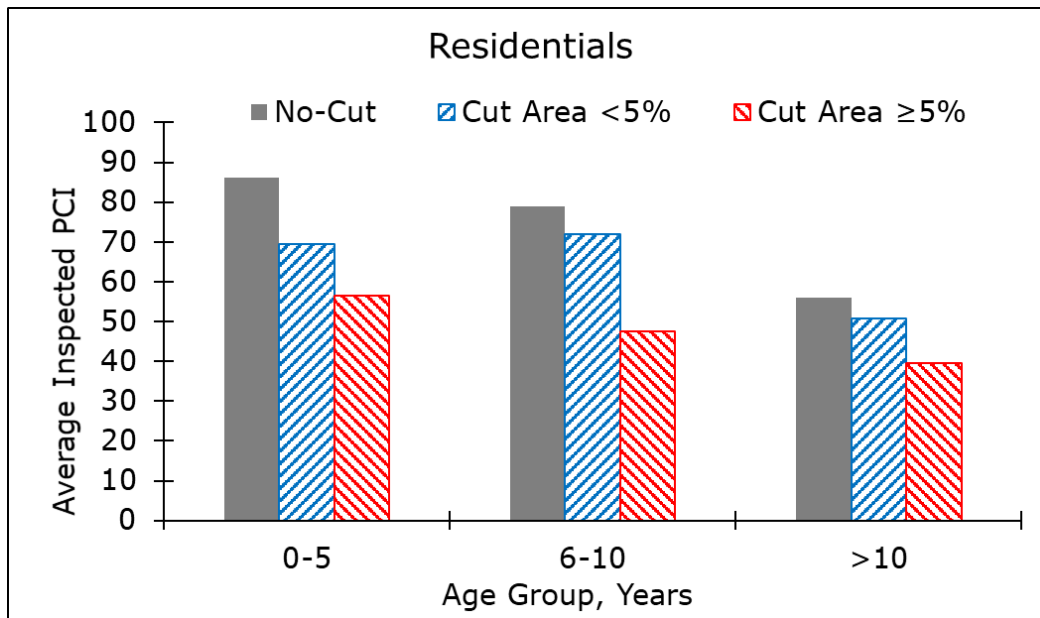
**Figure 14. PCI Comparison by Functional Class, Age Group and Cut Size – Residential**

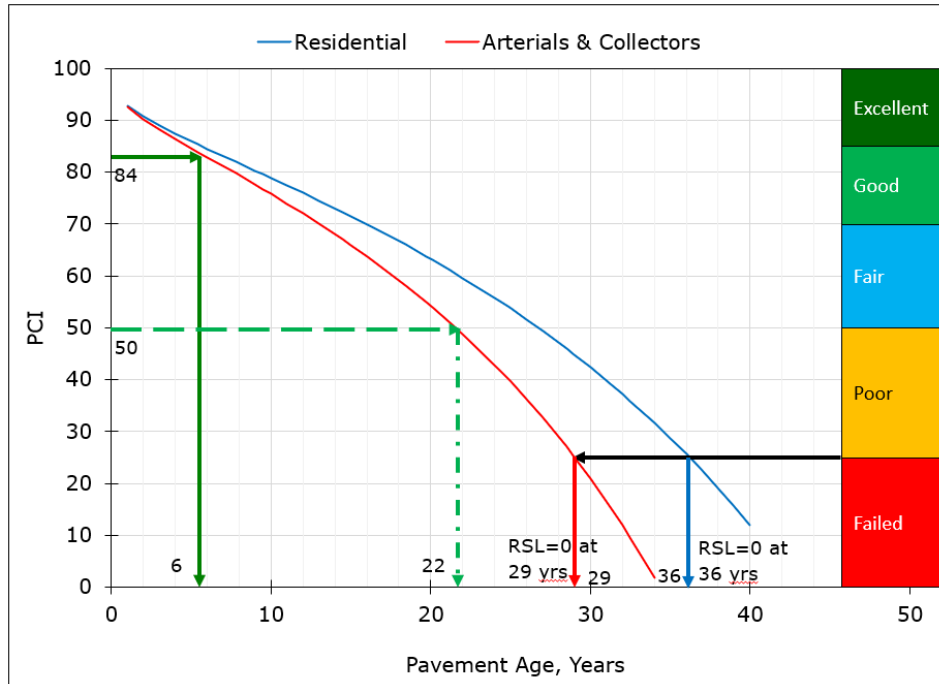
The percent reduction in pavement service life due to utility cuts was estimated using the StreetSaver® family deterioration curves for asphalt concrete streets, as shown in Figure 15. For example, assume an arterial/collector (aged 0-5 years) with no cut has a PCI of 84. A PCI of 84 for arterials/collectors corresponds to an equivalent service life of 6 years (shown by the solid green arrows on the figure). Based on the analysis in the previous section, a cut area greater than 5% of sample unit area would drop the PCI to 50; a PCI of 50 corresponds to an equivalent service life of 22 years (shown by the dashed green arrows on the figure). Consequently, the cut in this example reduces the pavement service life by 16 years, or 55% of its 29.5-year service life.

RSL = Remaining Service Life

**Figure 15. Pavement Family Deterioration Curves for Streets in Ukiah**

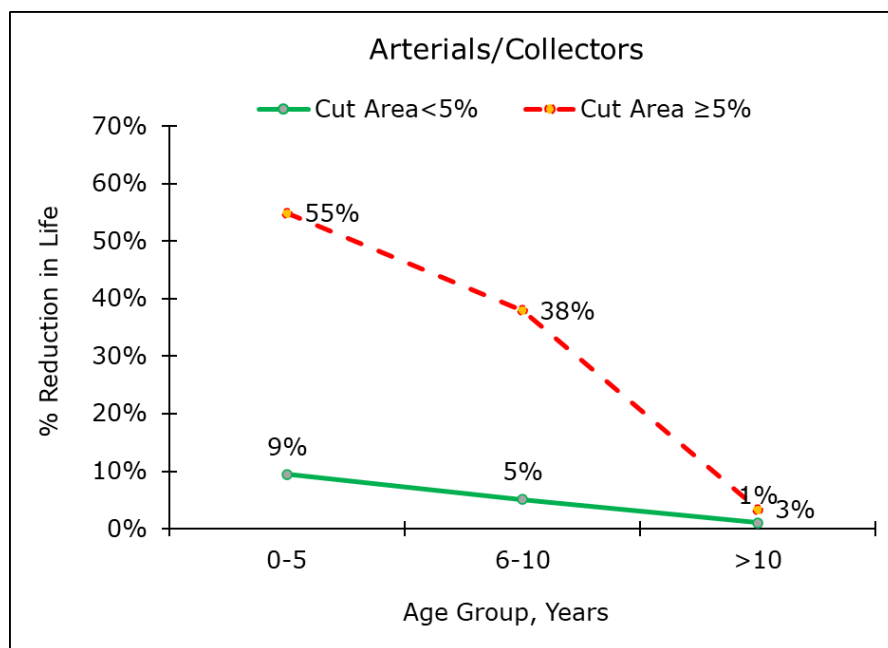
The above calculation was performed for both functional classes in all age groups and for all cut sizes to estimate the percent reduction in pavement service life. The results are illustrated in Figure 16 (arterials/collectors) and Figure 17 (residential).

**Figure 16. Percent Reduction in Pavement Service Life – Arterials/Collectors**

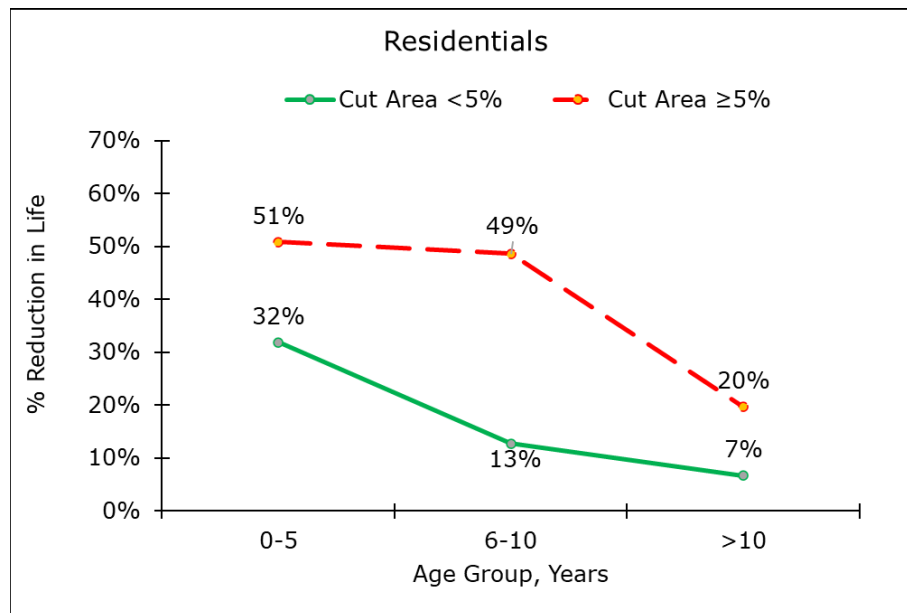
**Figure 17. Percent Reduction in Pavement Service Life – Residential**

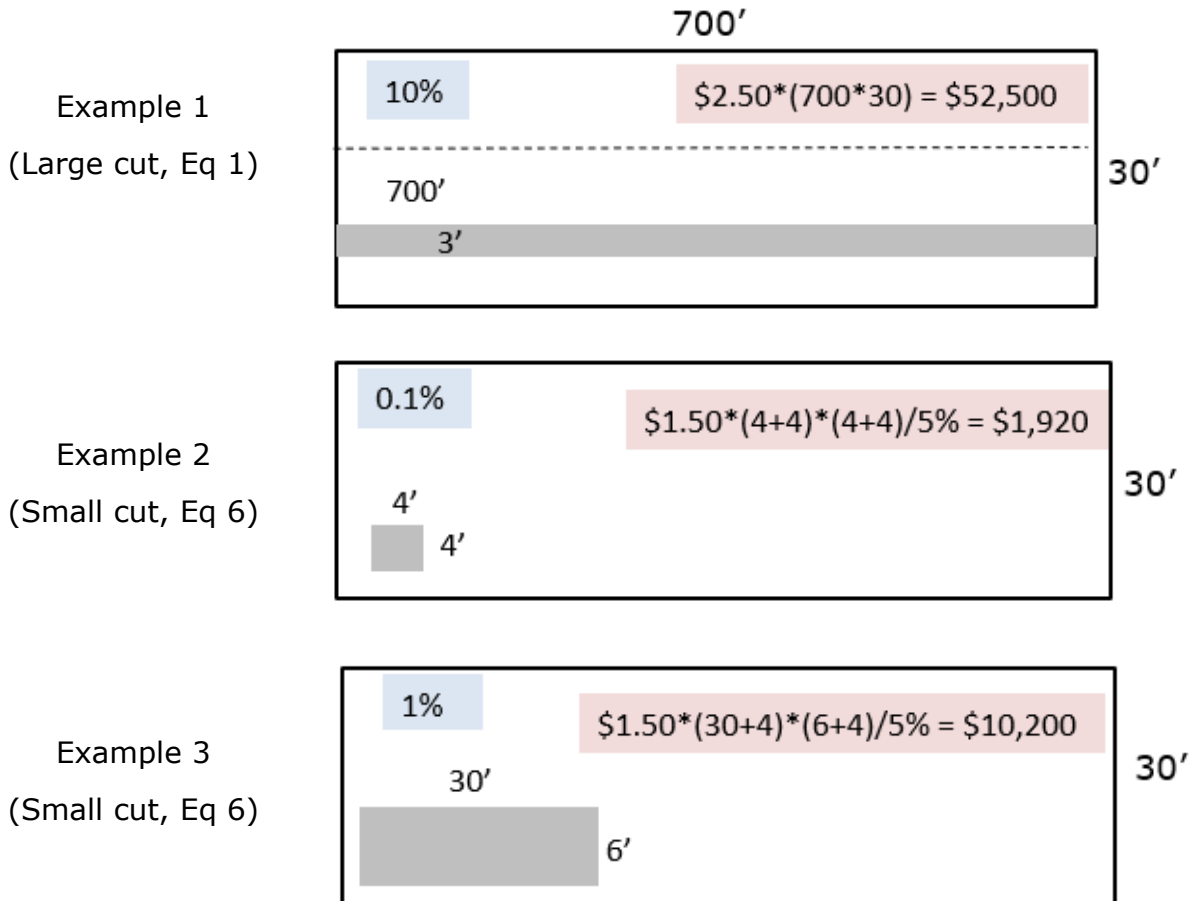
Figure 18 presents three examples of cuts of different sizes on residential streets. For large cuts, many full-block longitudinal trench cuts were observed in Ukiah (Figure 19). Based on the StreetSaver® database, the typical length and width of a residential street management section in the City is 700 feet by 30 feet, or an area of 21,000 square feet. Thus, full block longitudinal trench cut would be equal to or greater than 5% of the management section area, and thus \$2.50/square foot (Table 13) would be charged for the full recovery of the entire management section area (such as Example 1 below).

If a small cut (4 feet x 4 feet, or 16 square feet) is made to a residential street that is less than 10 years old, it would be only 0.1% of the management section area and the fee charged would be \$1.50/square foot (Table 13) for the cut area plus the area of the zone of influence.

A similar fee would be applied for a cut size of 30 feet x 6 feet (an area of 180 square feet), where the cut area is 1% of the section area.

**Figure 18. Examples of Fee Implementation for Typical 700'x30' Residential Street with Pavement Age < 10 years**

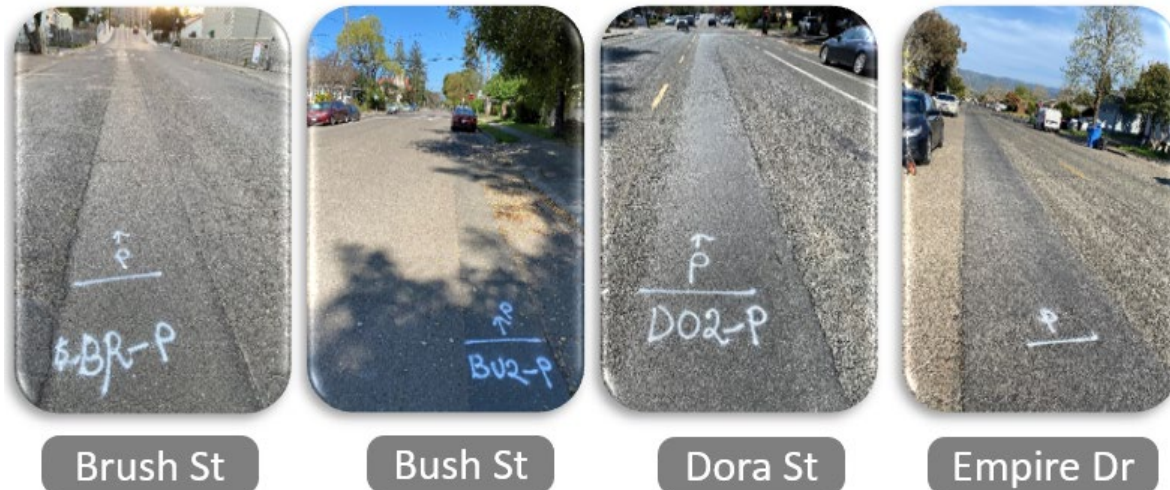
**Figure 19. Typical Full-Block Trench Cuts in Ukiah**

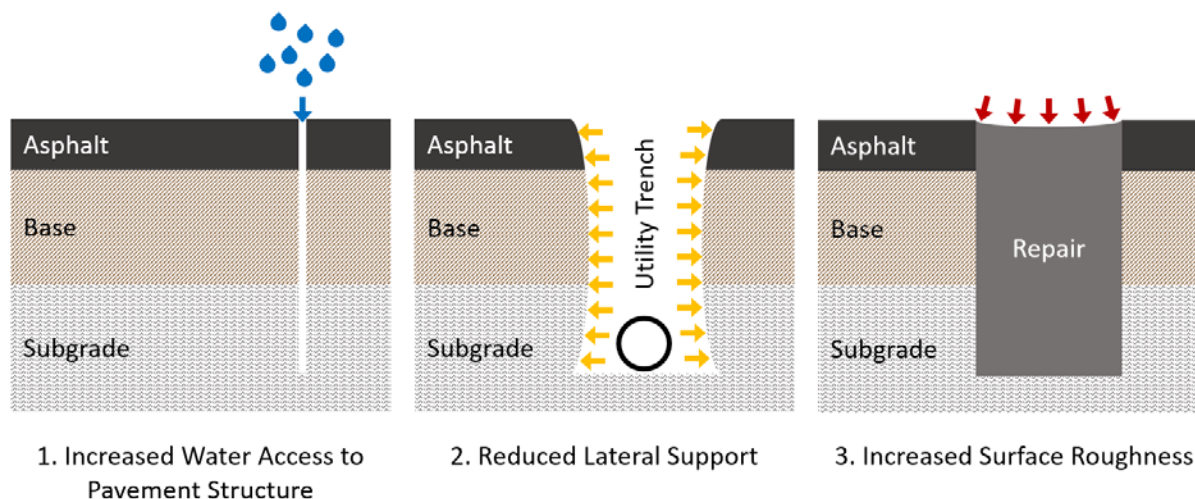
That said, underground utility work can damage pavements in three general ways as illustrated in Figure 1. First, the act of cutting a pavement structure creates an easy-access point for water to enter the pavement structure and damage the underlying pavement layers. Second, the removal of the pavement layers creates a plane of weakness where the pavement structure may not be adequately supported laterally – particularly during underground utility maintenance, but also after restoration. Third, the quality of the repair may not match the adjacent pavement structure, thus introducing roughness into the pavement. Rough pavements can cause vehicles to bounce, which creates greater loads on the pavement and leads to more rapid deterioration (Tarakji 1995; Wilde et al. 2002).

**Figure 1. Utility Cut Damage Mechanisms**

These deterioration mechanisms reduce the condition and structural capacity of a pavement, which reduces the life of the pavement within and adjacent to the utility cut (Stevens et al. 2010). Multiple utility cuts on the same street or within a small area can magnify this impact (Department of Public Works 1998, Tarakji 1995).

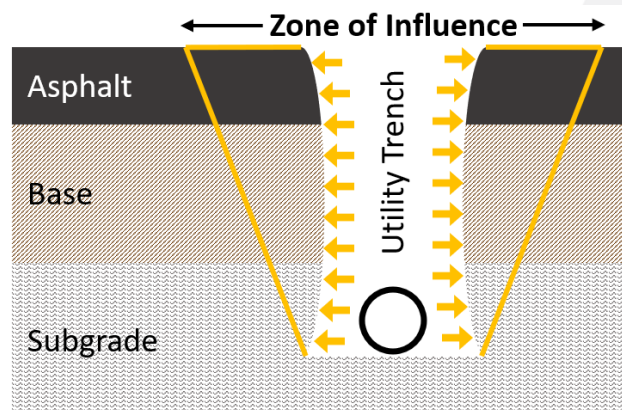
As previously mentioned, a utility cut can result in a loss of lateral support to the existing pavement structure surrounding the perimeter of the trench. This can cause the trench sidewalls to bulge into the trench and weaken the material under the existing pavement. This weakened area is termed the zone of influence, is illustrated in Figure 2.

**Figure 2. Zone of Influence**

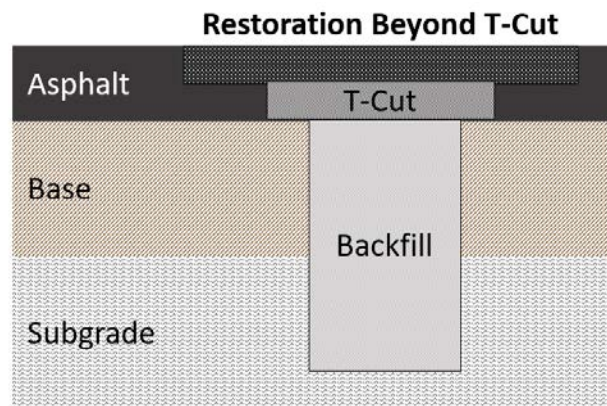
Utility cut restoration involves performing a treatment, in addition to adequate filling and compaction of the excavated area, to restore the pavement life and maintain the pavement's structural capacity and performance. Restoration often includes a T-Cut as well as another treatment, such as an overlay or surface seal, that extends beyond the length of the T-Cut arm. This restoration combination is illustrated in Figure 3.

T-Cuts involve cutting back a portion of the pavement surface beyond the edge of the trench to better protect the zone of influence and bridge the plane of weakness. Such repairs have been found advantageous in the restoration of utility cut trenches by alleviating the effects of the lateral support loss due to the excavation (Peters 2002; Stevens et al. 2010). Research has shown that the thickness of the restoration, the quality of materials used, and the placement and compaction methods of fill materials are key factors in ensuring strong pavement performance in future years (Jensen et al. 2005; Stevens et al. 2010; Todres and Baker 1996).

**Figure 3. Example Restoration Plan.**
