Palace Hotel Inspection 9/29/2023

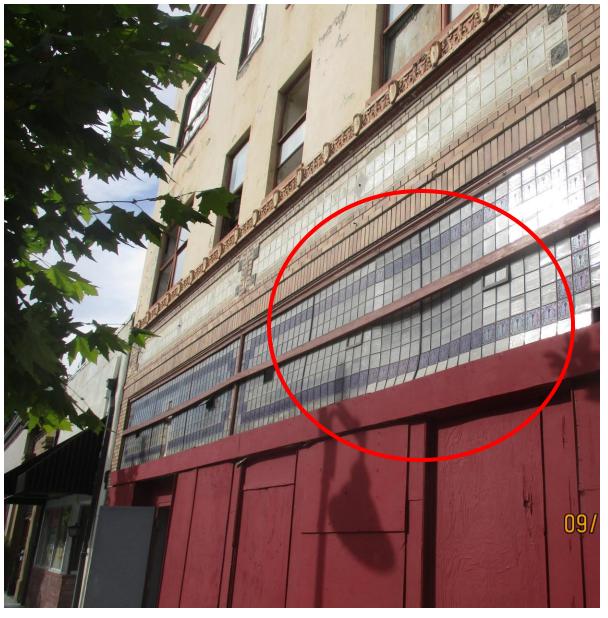
LEAD GLASS FAILURE STATE ST

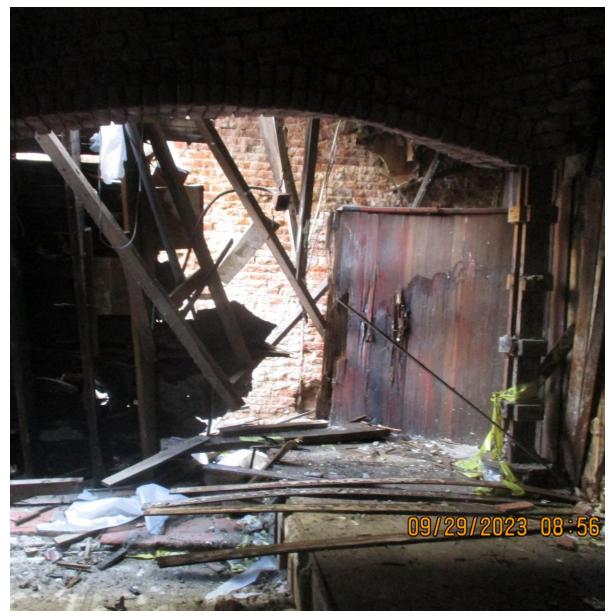
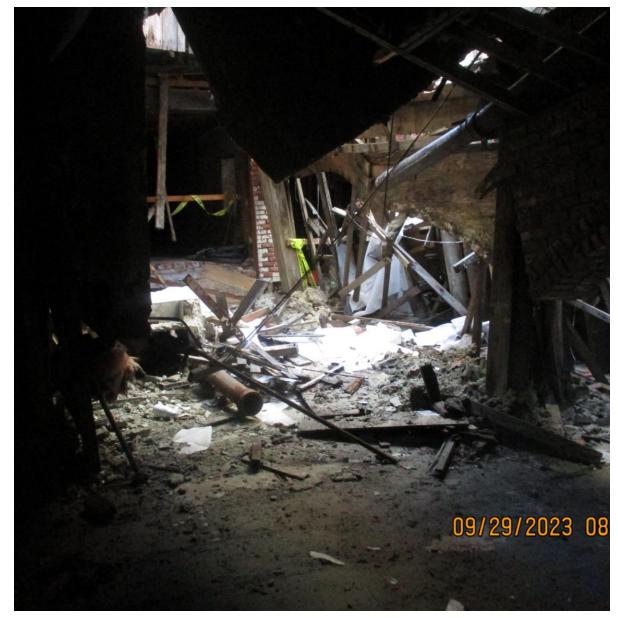
1ST FLOOR: 2ND FLOOR STRUCTURAL FAILURE

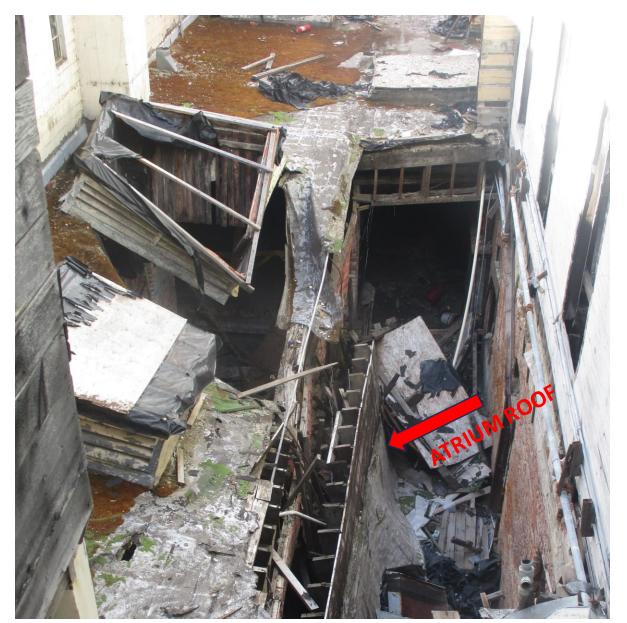
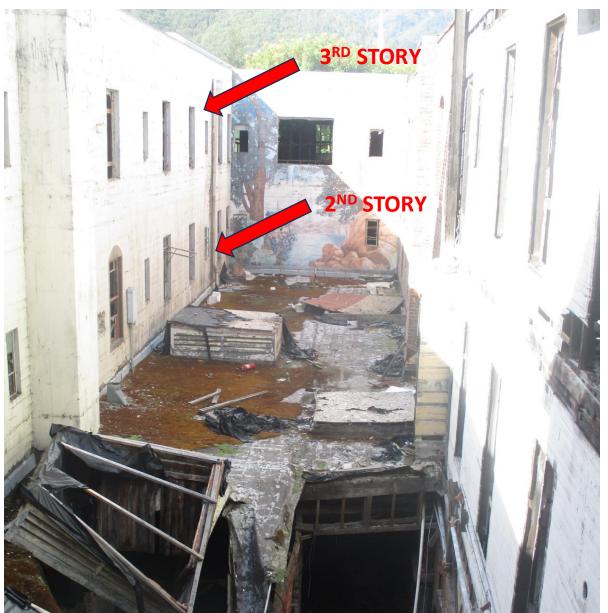
3RD FLOOR COLLAPSED ATRIUM FROM ABOVE
